JBA
consulting

River Blythe Restoration Plan

May 2017

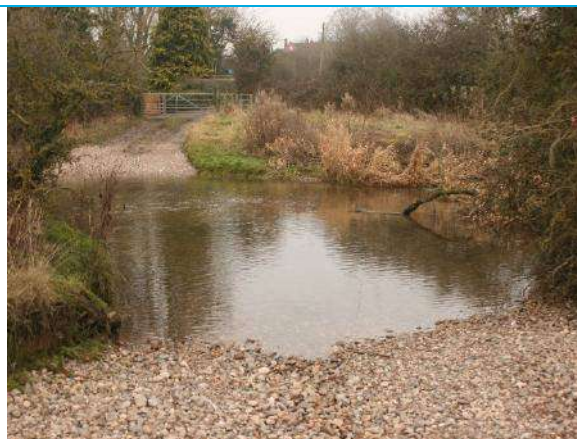
An over-widened section of the River Blythe

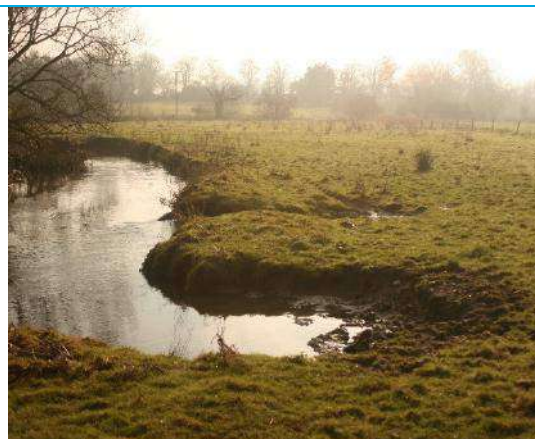
Active erosion enhanced by poaching

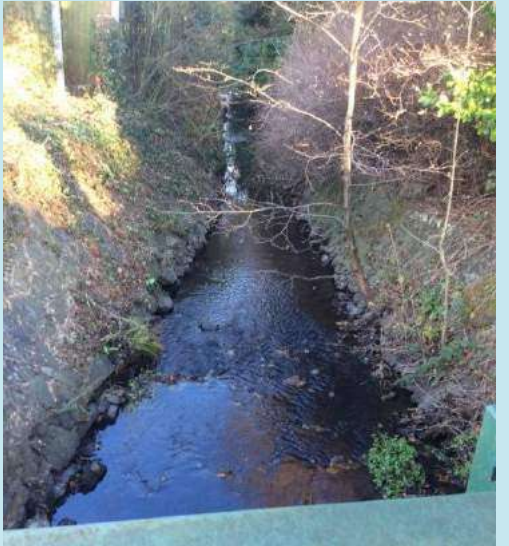
<p>Concrete-lined, entrenched channel near Coppice Walk. Channel width is uniform throughout reach.</p>

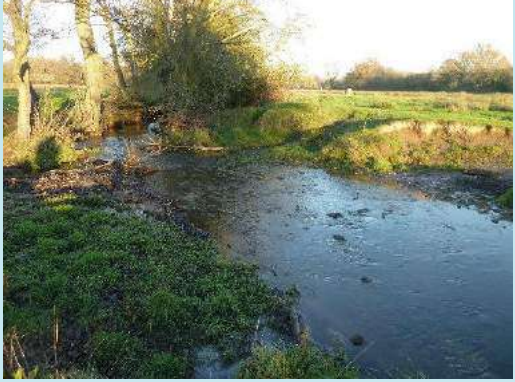
<p>Ford crossing over shallow, riffle, resulting in broken banks.</p>

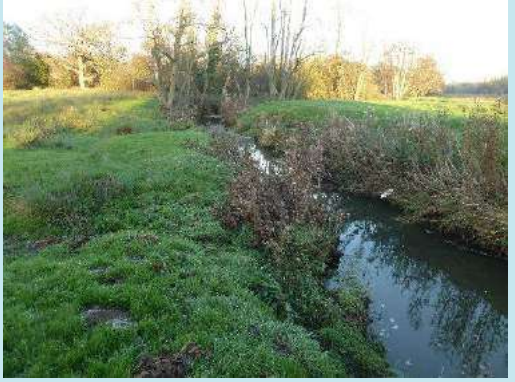
<p>In addition to riffles, there are also deep, slow-moving areas of the channel, in which some suspended silts are evident.</p>

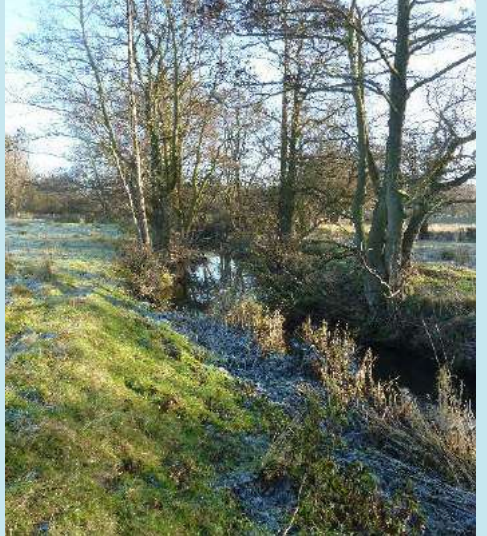
<p>Incised channel, Alder-lined for most of the reach with occasional Crack Willow pollards.</p>

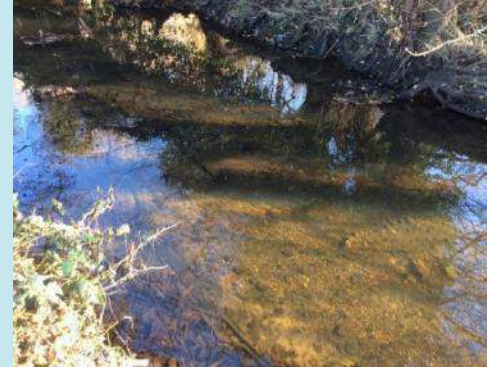
<p>Bed substrate in riffles and shallow sections is shown to be mostly armoured gravels with sandy deposits and some fine sediments, colonised by Water Crowfoot in places.</p>

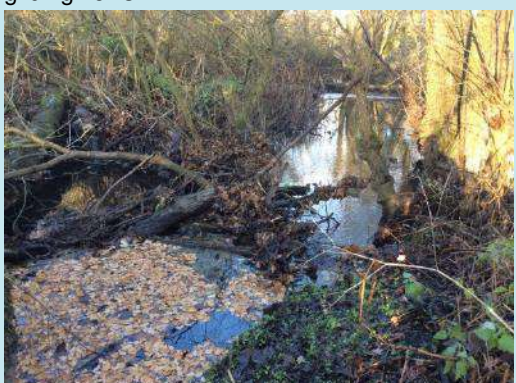
<p>Through Halfmoon Coppice wood the channel is wide and slow-moving, owing to localised impoundment caused by natural dams. Floodplain connectivity is generally poor.</p>

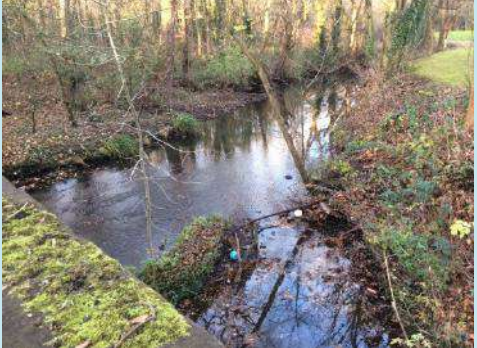
<p>Gravel deposition on left-hand bank margin.</p>

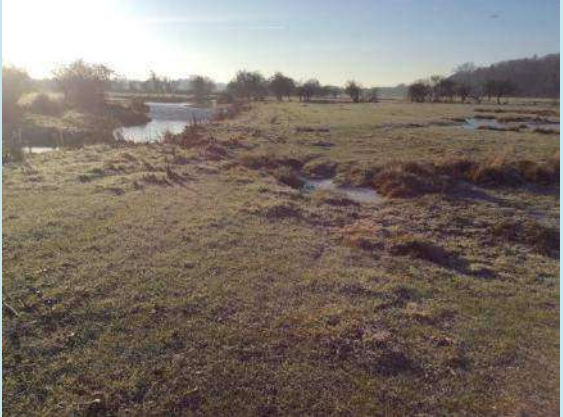
<p>Extensive network of paleo channels evident in floodplain, some of which contain Soft Rush..</p>

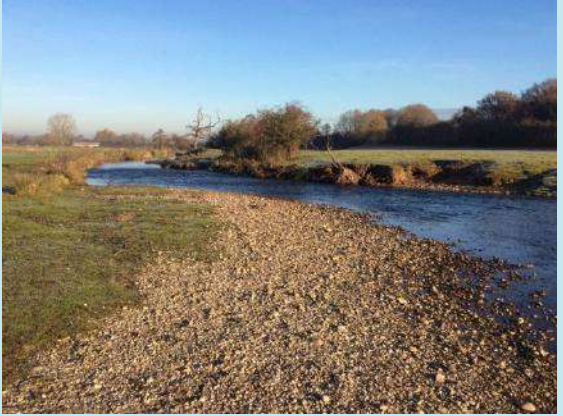
<p>Areas of active deposition being colonised by heavily grazed grassland.</p>

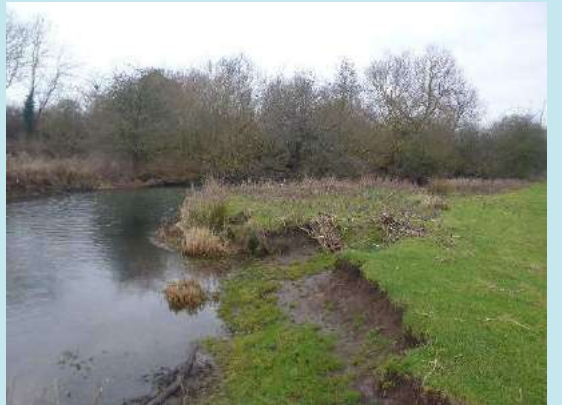
<p>Bank erosion caused by grazing and formation of island from the former bank line.</p>

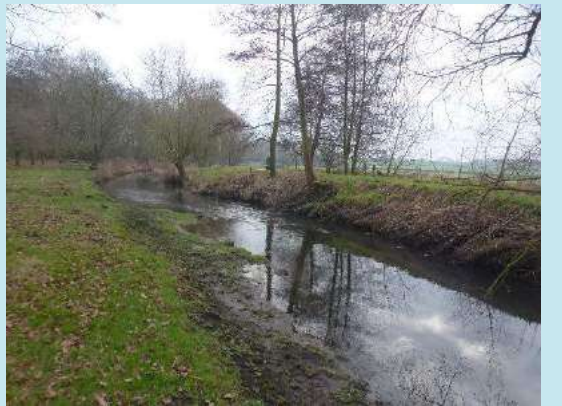
<p>Fine sediment deposition on relatively straight section. Different bank profiles resulting from differences in management practices.</p>

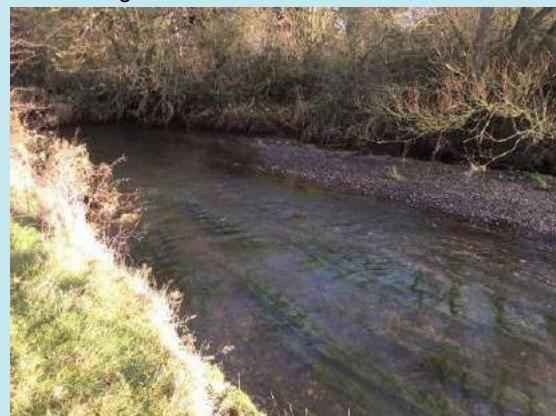
<p>Some small point bars have developed at bends in the channel; these contain small gravels and fines, colonised by Stream Water-crowfoot.</p>

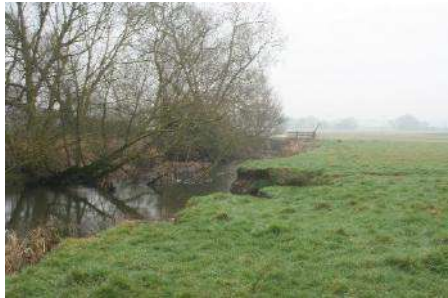
Lack of Floodplain Connectivity Several factors contribute to this including embankments concentrating in channel flows and channel incision and entrenchment as the surrounding floodplain has been partly built up around the channel.	A reduction in the frequency of floodplain inundation means that fine sediment is deposited within the channel and not on the floodplain. Excess fine sediment within the channel will reduce spawning habitats and also decrease the quality of the substrate for some taxa. Ultimately, excessive fine sediment is a major cause of in channel habitat degradation and leads to poor ecological condition.

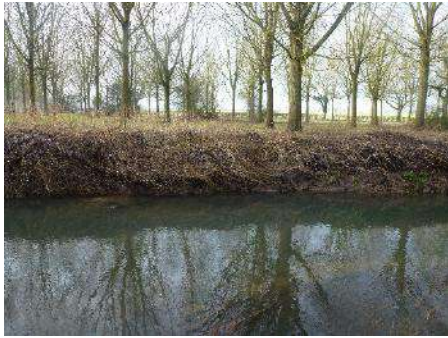
Bank Instability and Livestock pressures Bank instability as a result of poaching from livestock, poor farming practices in places, and entrenchment of the channel.	Livestock have utilised the collapsed banks to gain access to the river in a number of locations leading to enhanced erosion of the banks (poaching). Arable farming, where carried out up to the channel edge, has limited riparian vegetation cover and exacerbated bank erosion. Increased input of fine sediment into the channel which leads to increase in channel siltation. A more uniform channel reduces the habitats within the river (i.e. fewer refuges for shelter). Limited bankside vegetation due to erosion and as a result a decline in habitat.

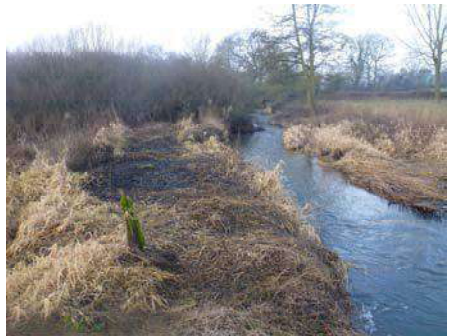
Invasive Species Including Japanese Knotweed, Himalayan Balsam, Cotoneaster, Snowberry and waterweeds (<i>Elodea sp.</i>) were noted along the watercourse	Dieback of invasive species during winter months' leaves banks exposed and prone to erosion. Some bankside areas are heavily colonised. Waterweeds can dominate in-channel vegetation leading to a monoculture and reduction in overall diversity within the channel. Quickly spread and can lead to a decline in native species

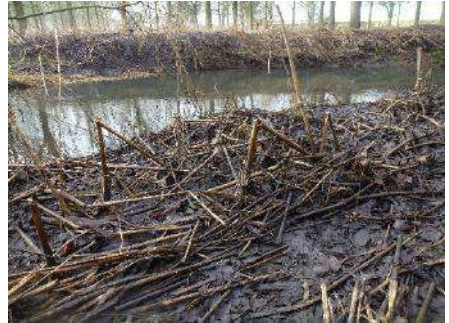
Channel Training Bank revetment, which is a form of channel training, is present in certain reaches along the river in various forms ranging from walling to blockstone.	Reduced channel maintenance means that areas of historic protection are now failing and the channel response in the form of lateral erosion must be planned for.

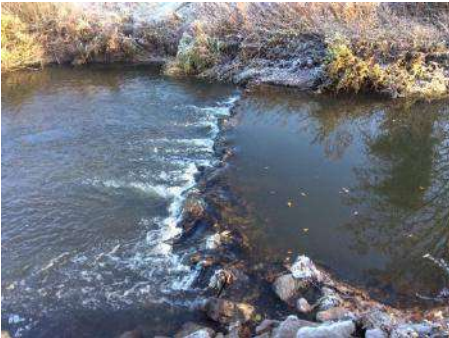
<p>Discharge: Abstraction, Diversion and Impoundment of flows</p> <p>Earlswood Lakes, constructed between 1822 and 1823 for the purposes of retaining water levels in the Stratford upon Avon canal via flow diversion, and the reservoir at Whitacre used for public water supply, certainly impact the flow regime of the River Blythe.</p>	<p>Whilst not considered to affect the low flows through the River Blythe, the large impoundment reservoirs at Earlswood Lakes attenuate large volumes of water and will impact by reducing high flows being released into the channel. Limiting the high flows in the upper catchment impacts upon sediment transport mechanisms.</p>
