River Cole Feasibility and Design

Final Report

Warwickshire Wildlife Trust

Document Type: Final report

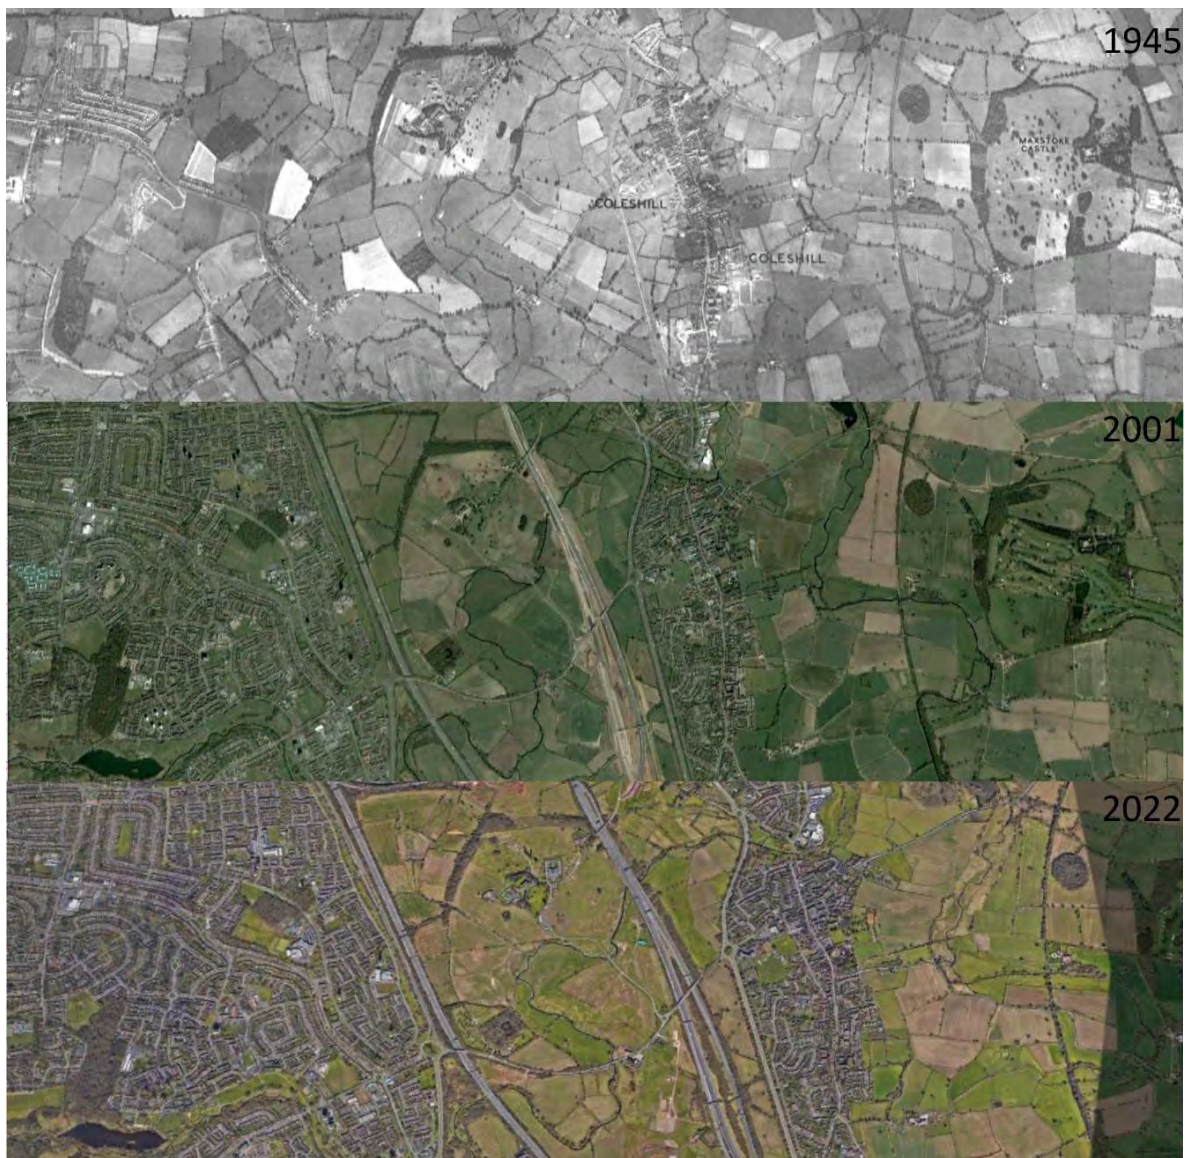
Figure 2-8: Satellite imagery from 1945, 2001 and 2022, showing the increase in urban land cover within the River Cole catchment. Data: Google Earth.

Land use and land cover patterns within the catchment will provide controls over the influx of water, sediment, with urban land covers contributing to increased runoff. In order to determine both the historic and current land cover utilisation, historic and modern aerial photography were reviewed to assess changes to the catchment land cover and land use over time. Analysis of satellite imagery (Google Satellite, 2023) shows a large increase in urban/residential land cover between 1945 and 2001, with the development of Solihull and Kingshurst. Further development post 2001 was insignificant, see Figure 2-8.

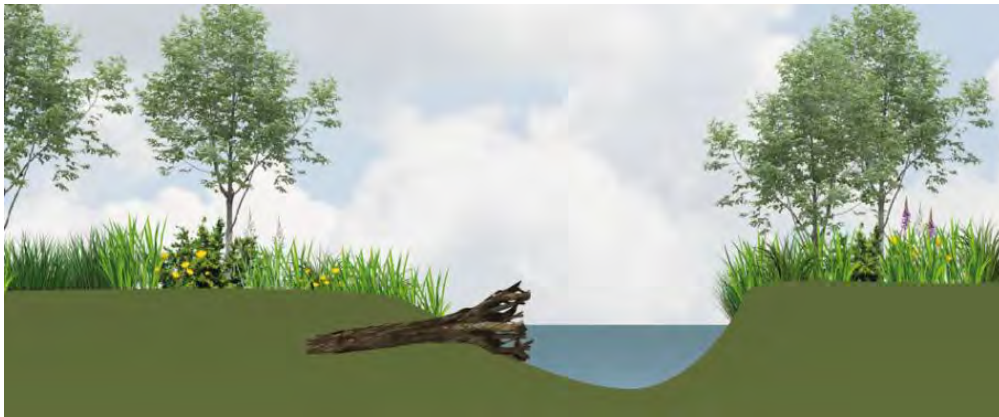
Reach	Cooks Lane to M6	Option	2. Minimal intervention
Description <ul style="list-style-type: none"> Retain flow through existing channel. Introduce alternating large wood structures (LWS) at carefully targeted locations to further improve habitat diversity in main channel, with placement guided by detailed physical assessments. 			
Indicative cross-section

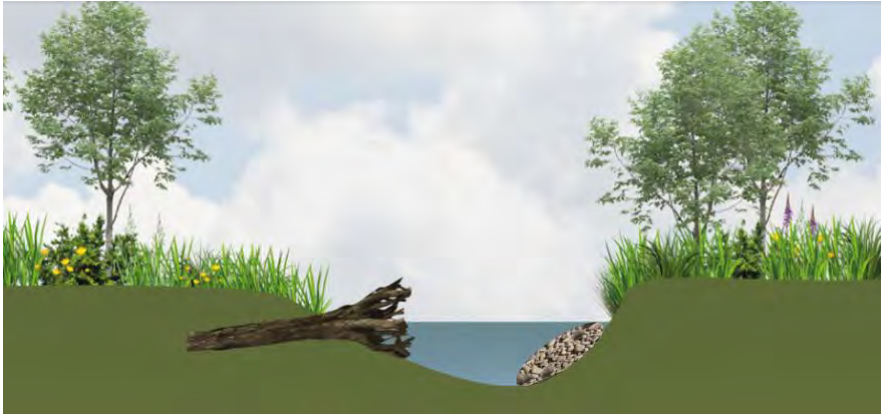
Reach	Cooks Lane to M6	Option	3. Partial intervention
Description <ul style="list-style-type: none"> Option 2, plus: Introduce gravels to create bar and berm features, and augment existing berms to improve geomorphic variability. Manage existing vegetation to improve the stability of existing berms. 			
Indicative cross-section

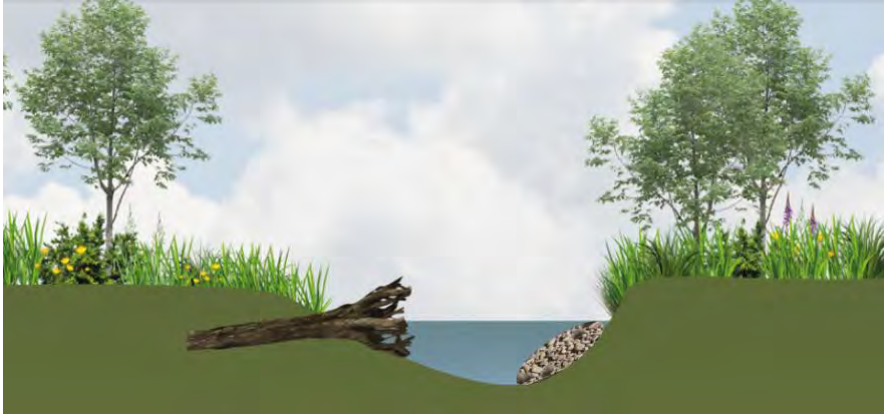
Reach	Cooks Lane to M6	Option	4. Full intervention
Description <ul style="list-style-type: none"> • Retain flow through existing channel. • Introduce alternating LWS at carefully targeted locations to further improve habitat diversity in channel, with placement guided by detailed physical assessments. • Introduce gravels to create bar and berm features, and augment existing berms to improve geomorphic variability. Manage existing vegetation to improve the stability of existing berms. • Complete removal of the gauging weir to fully restore fish passage, transfer of sediment and nutrients, and reinstate natural form and processes. If permissions for removal of the weir are difficult to obtain, installation of a fish pass could also be considered. 			
Indicative cross-section

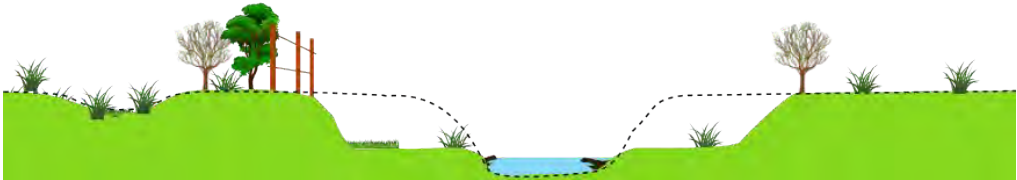
Reach	HS2 Land	Option	3. Partial intervention
Description <ul style="list-style-type: none"> Retain flow through existing channel. Reprofile banks (potentially incorporating bed raising and/or creation of two-stage channel) and remove localised embankments to improve channel/floodplain connectivity. Utilise relict channels as floodplain features. Introduce alternating LWS at carefully targeted locations to further improve habitat diversity in channel, with placement guided by detailed physical assessments and designed to complement existing structures. Maintain natural riparian woodland vegetation where already present (particularly around the reaches upstream extent) and enhance vegetation along reprofiled banks for additional stability. 			
Indicative cross-section

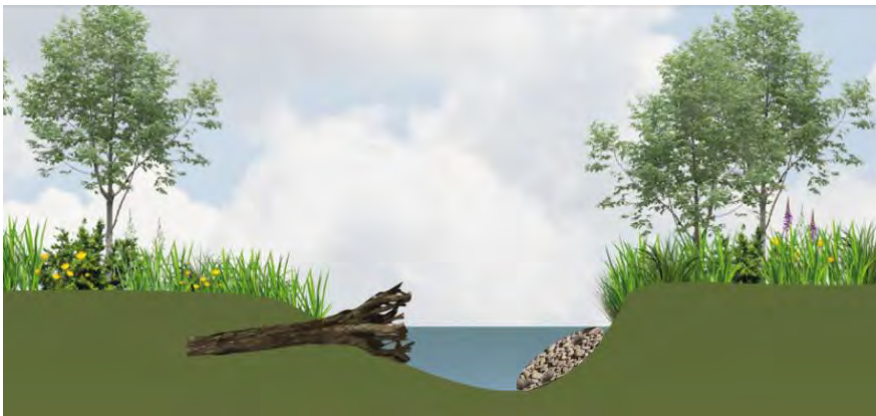
Reach	Coleshill to Quarry	Option	2. Minimal intervention
Description <ul style="list-style-type: none"> In the upstream extent, use relict channels as floodplain features. Introduce alternating large wood structures (LWS) and introduce, or augment existing, gravels at carefully targeted locations, to further improve habitat diversity in main channel. 			
Indicative cross-section

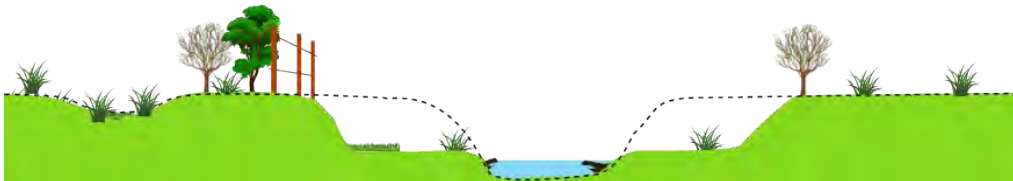
Reach	Coleshill to Quarry	Option	3. Partial intervention
Description <ul style="list-style-type: none"> In the upstream extent, use relict channels as floodplain features as well as reprofiling the banks to increase floodplain connection. Remeandering of the channel through the parkland area in Coleshill to improve geomorphic variability. Introduce alternating large wood structures (LWS) and introduce, or augment existing, gravels at carefully targeted locations, to further improve habitat diversity in main channel. 			
Indicative cross-section

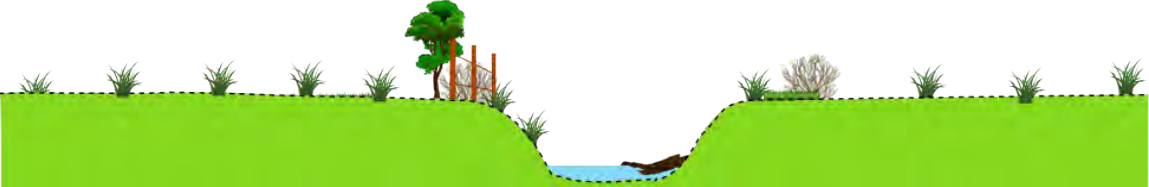
Reach	Coleshill to Quarry	Option	2. Minimal intervention
Description <ul style="list-style-type: none"> Retain flow through existing channel. Introduce alternating large wood structures (LWS) at carefully targeted locations to further improve habitat diversity in main channel, with placement guided by detailed physical assessments. 			
Indicative cross-section

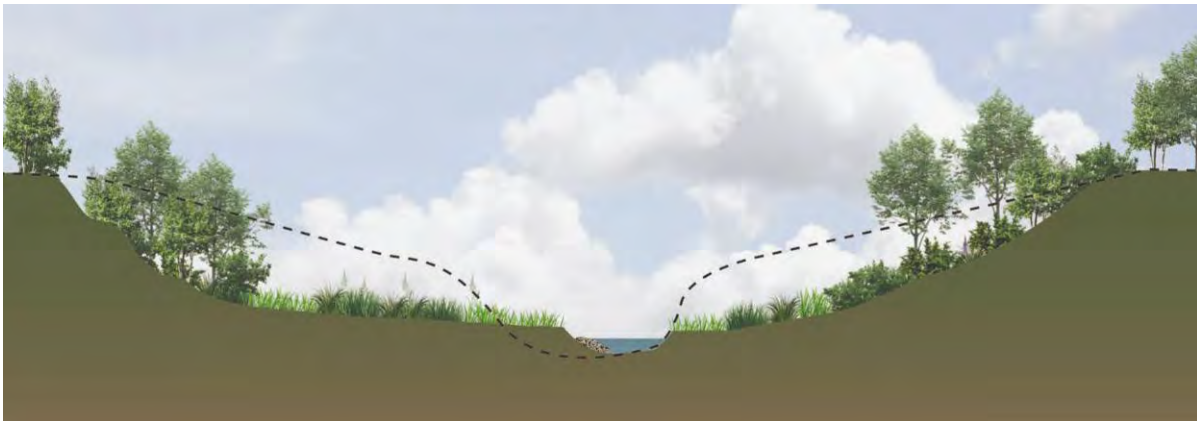
Reach	Coleshill to Quarry	Option	3. Partial intervention
Description <ul style="list-style-type: none"> Retain flow through existing channel. Introduce alternating LWS and gravels at carefully targeted locations to further improve habitat diversity in channel, with placement guided by detailed physical assessments. Introduce gravels to create bar and berm features, and augment existing berms to improve geomorphic variability. Manage existing vegetation to improve the stability of existing berms. In selected areas, set back the embankments to create in-set floodplain/wetland areas. 			
Indicative cross-section

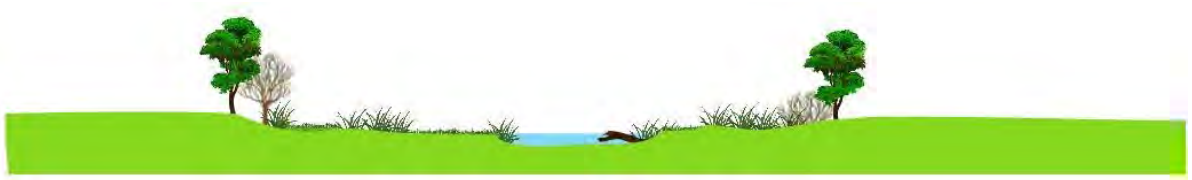
Reach	Coleshill to Quarry	Option	4. Full intervention
Description <ul style="list-style-type: none"> Full removal of embankments and infilling of current channel to create a 'stage-0' restoration approach, allowing full reconnection between the river and disused quarry land. Introduce alternating LWS at carefully targeted locations across the floodplain area to force channel natural geomorphic processes, leading to unassisted channel development over an extended time period. Extensive planting of native trees and vegetation to create a floodplain mosaic across which the river will meander freely. 			
Indicative cross-section

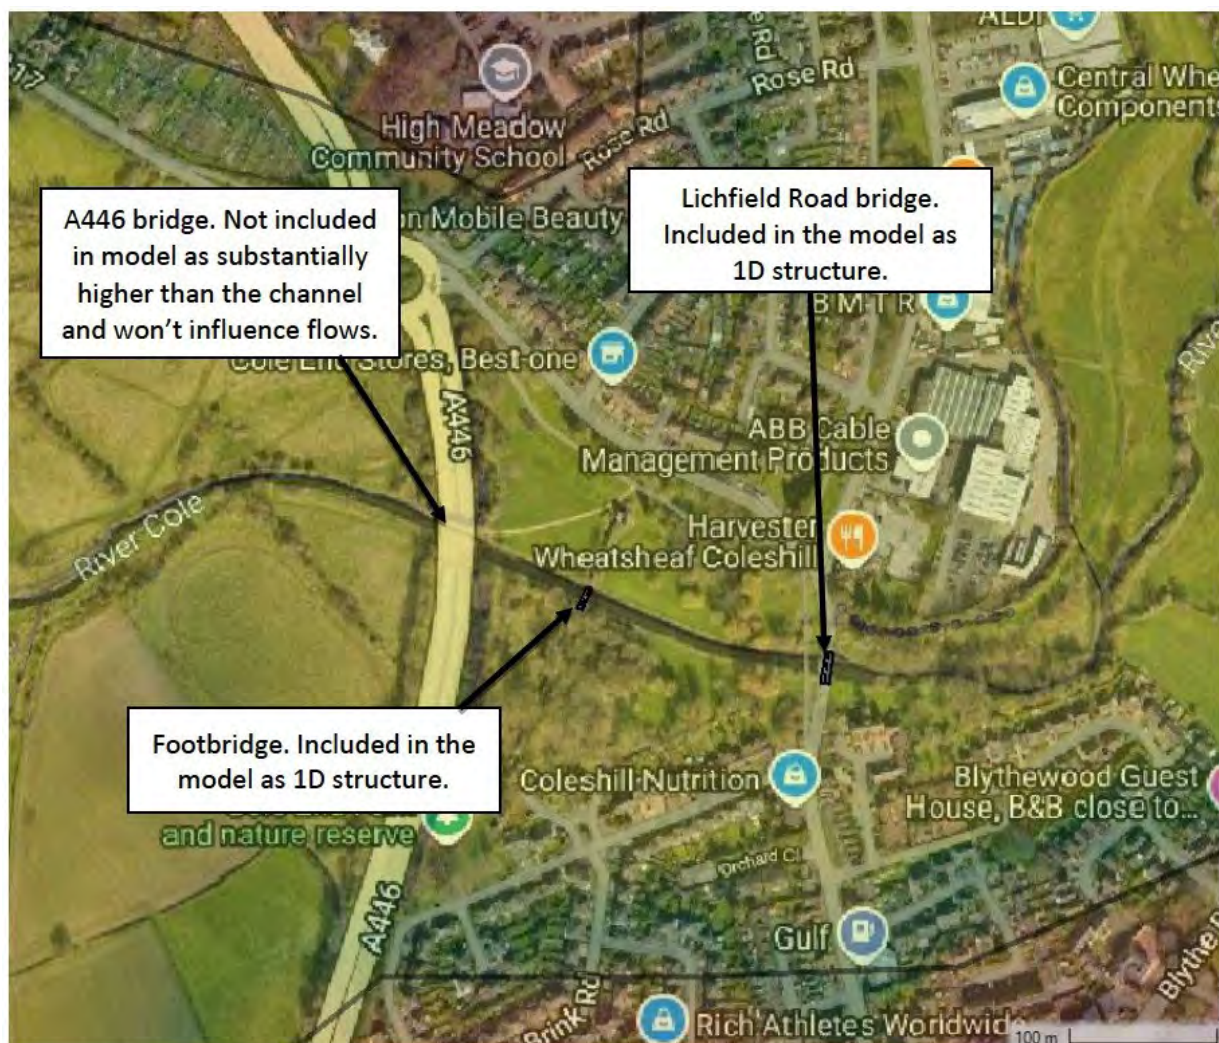
Figure 6-3. **Bridges** included in the model.

There are several bridges in the model area, shown in Figure 6-2 and Figure 6-3. The bridges were reviewed to determine whether they would impact the channel flow. The large road bridges for the M42 and A446 are significantly larger than the channel and the decks would not affect the channel flow. The abutments do present a narrowing of the flow path (out of bank), but these are included in the model terrain.

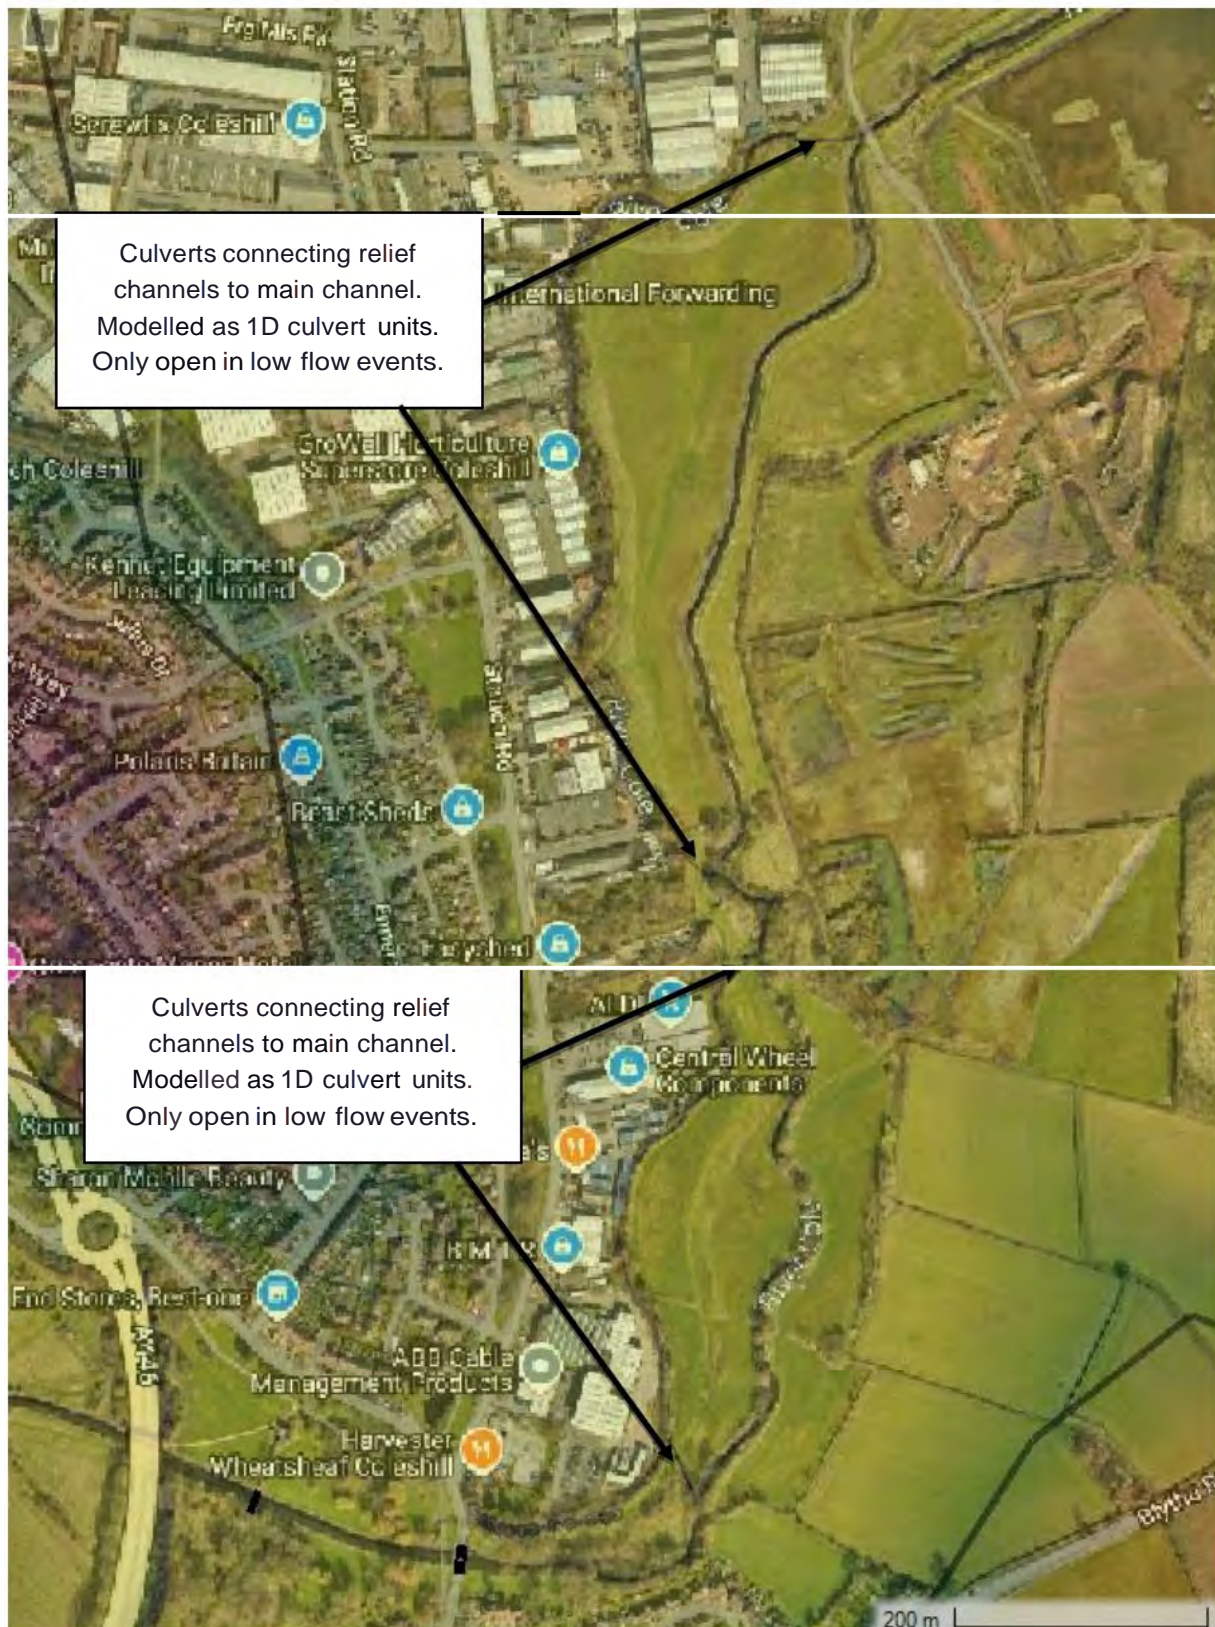
The culverts are included in the model as 1D structures.

Figure 6-4. Culverts connecting relief channels to main channel.

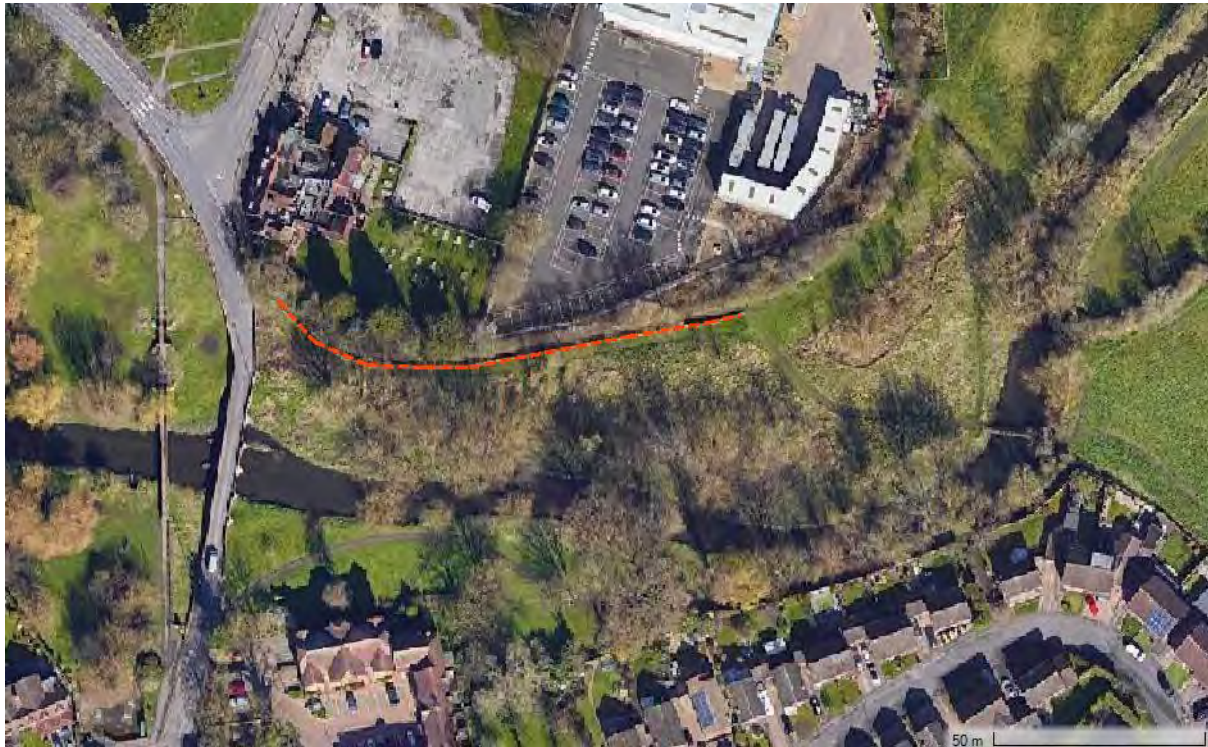
Figure 6-5. Location of flood defence wall.

There is an EA flood defence asset, a wall located behind the car park behind the Harvester, on the left of the channel (see Figure 6-5). The EA was contacted for information about this wall and confirmed the crest elevation is 74.4 mAOD. This was incorporated into the model using the terrain modification functionality in HEC-RAS.

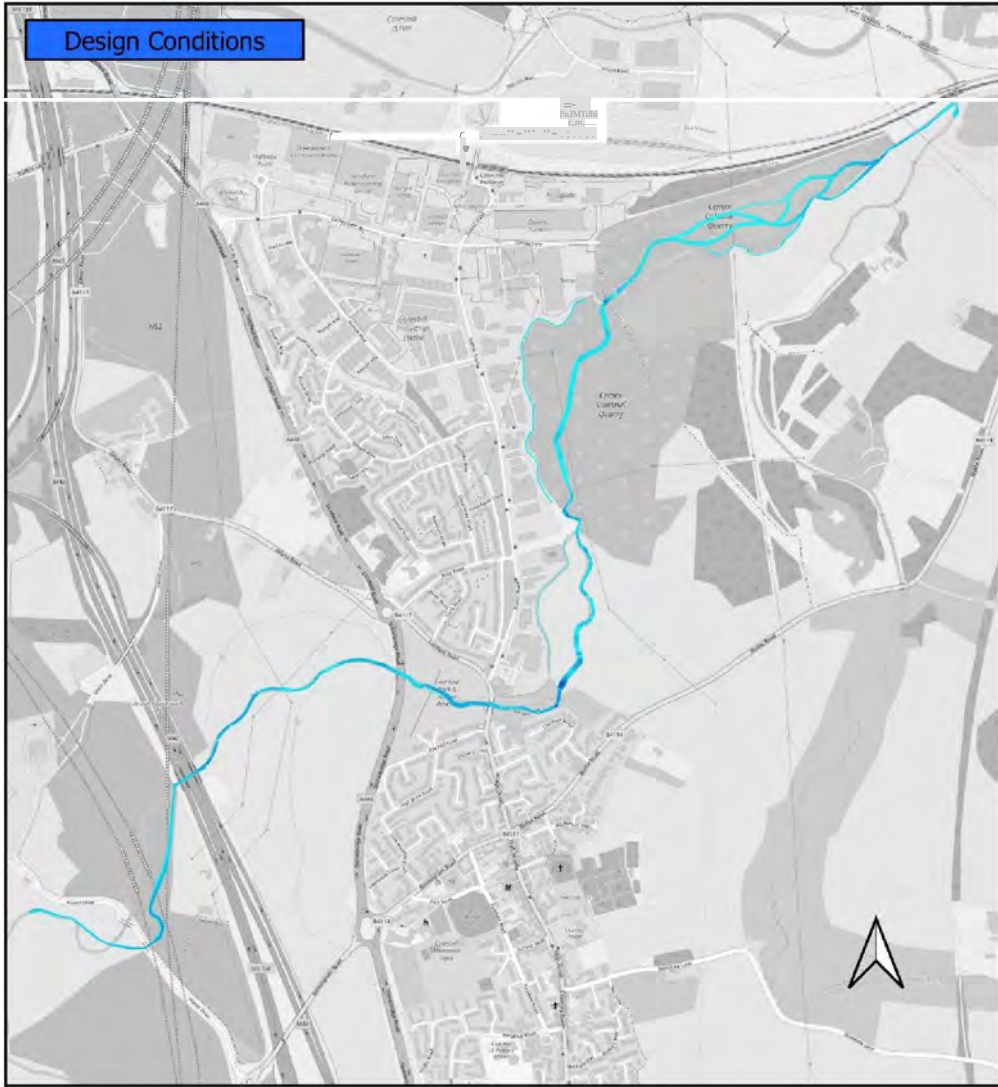
In the 1 in 10 years event, the design reduces flooding to the industrial area left of the river (e.g. along Station Road). This is also apparent in the 1 in 30 years event. For the 1 in 100, 100 plus climate change and 1,000 years events, this improvement is no longer seen. For the 1 in 100 and higher events, the design shows reduced flooding in the Coleshill Quarry, on the right bank of the river.

For all events, the design shows increased flood extents in the floodplain on the right bank of the River Blythe. The Blythe was not included in the model, though the channel is present to some degree in the LIDAR. Based on EA flood maps of the area though, this will be dominated by the Blythe flooding. As previously noted, it was outside the scope of this assessment to carry out joint analysis of flooding on both rivers interacting. The focus for this assessment was solely on the River Cole and how the design performs there.
