JBA
consulting

River Blythe Restoration Plan

May 2017

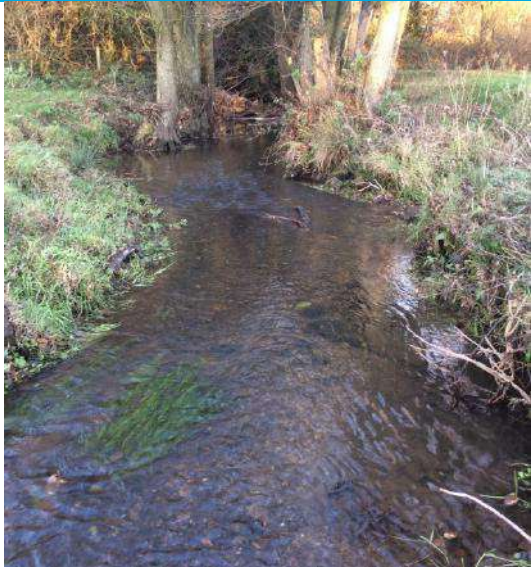
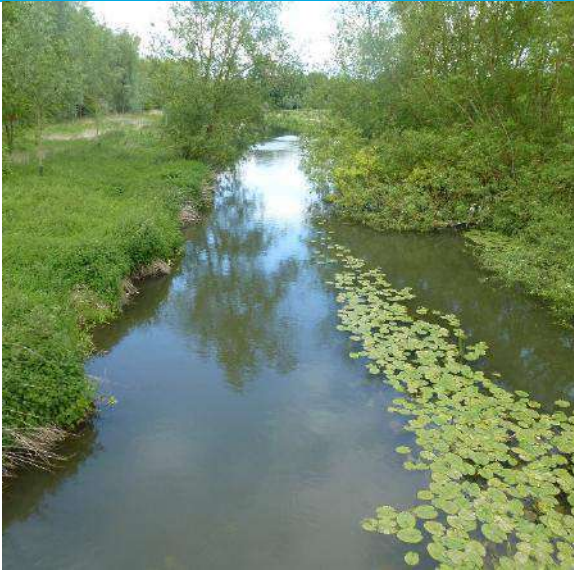
Table 1-1: Example photos of well-functioning reaches

<p><i>The River Blythe upstream of Blythe Valley Park (413214, 275539) - an example of what the river should look like; sinuous, well connected to the floodplain, bed substrate comprising gravels and sands and free of fine sediment, gentle gliding flows. Alder-lined banks, in -channel vegetation (Water Crowfoots).</i></p>	<p><i>The River Blythe downstream of Blythe Bridge (421073, 289940) - although the channel is slightly wide initially owing to bridge, the channel in this reach is gently sinuous and well connected to its floodplain.</i></p>

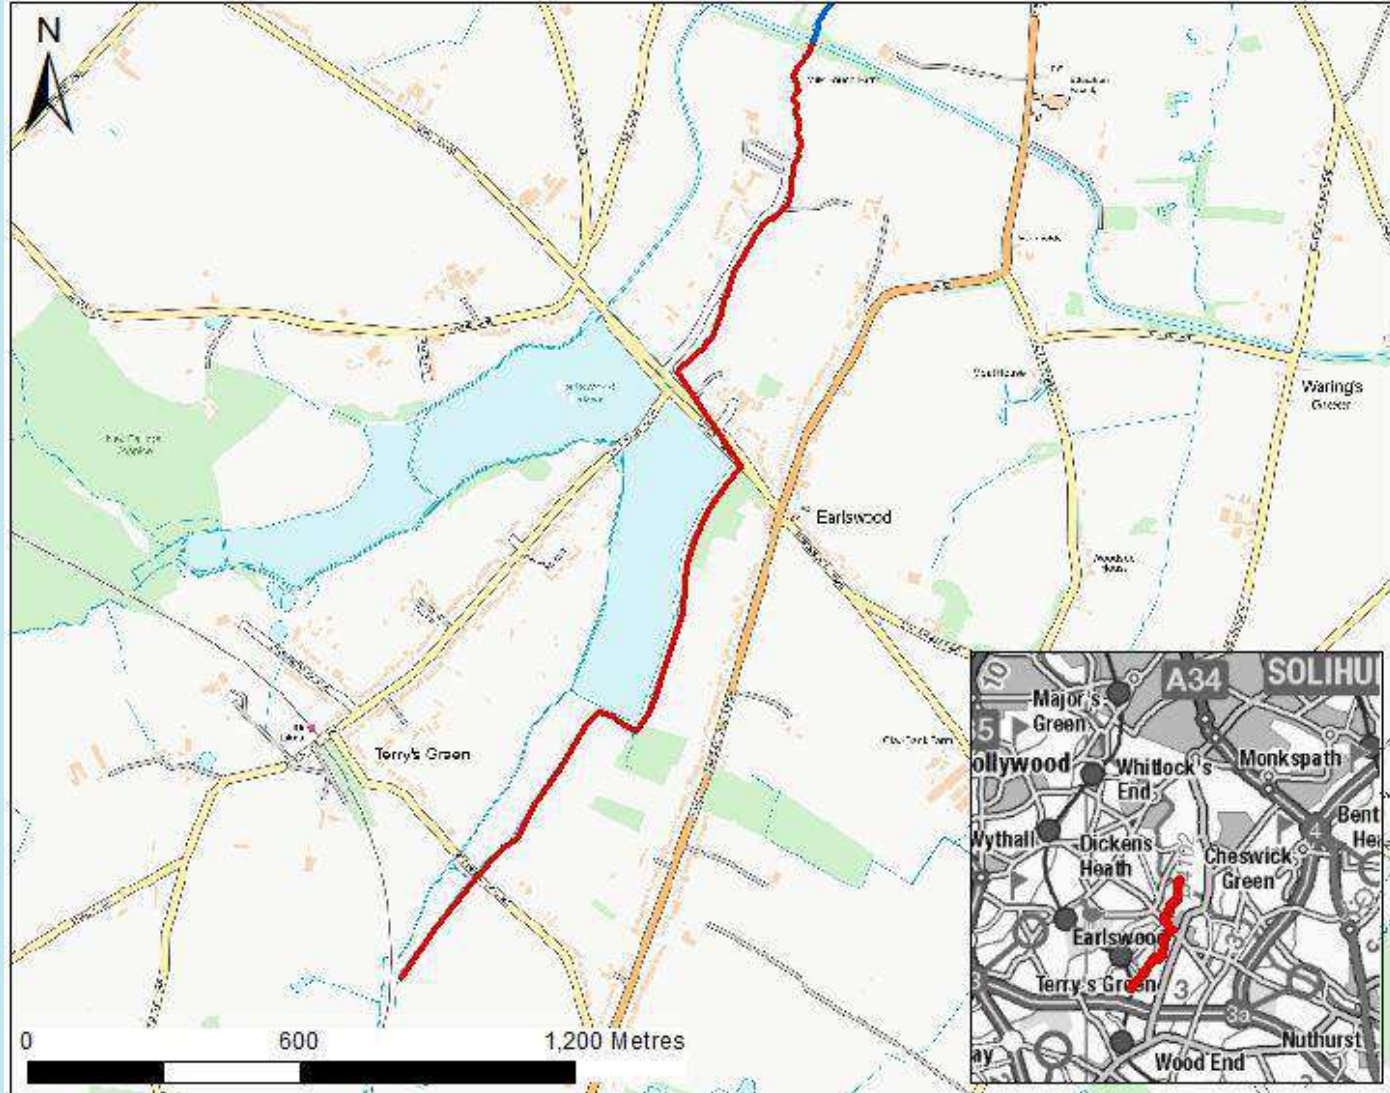
4.3.1 Reach 1: Earlswood

Reach Details	Existing Reach Conditions	Reach Overview	Photographs
<p>Start NGR: SP 11471 74249</p> <p>End NGR: SP 11768 74976</p> <p>Reach Length: 843m</p> <p>SSSI Unit: Unit 2</p> <p>SSSI Unit Condition: Unfavourable Recovering</p>	<p>Geomorphology:</p> <ul style="list-style-type: none"> River type is passive meandering. The channel has been significantly physically modified during the construction of the reservoirs, including channel straightening and diversion upstream. A transporting reach with minimal areas of active deposition. Primarily a riffle-glide sequence, with some pools behind natural dams. Flow variation created by natural dam features formed by large woody material. Incised channel with moderate to poor floodplain connectivity, but localised impoundment caused by natural dams. Armoured gravel bed with sands. <p>Ecology:</p> <ul style="list-style-type: none"> Channel is Alder-lined with large amounts of large woody material. Alder roots form small weirs creating varied morphology. One stand of Japanese Knotweed associated with buried utilities. Gravel bars being colonised by Fools Water-cress. Land abandonment and reversion to wet grassland and fen along floodplain. Potential pollution risks from industry.

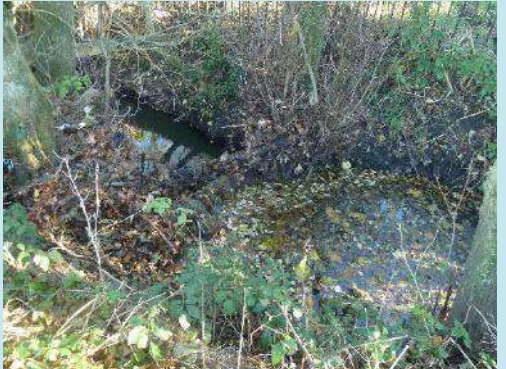
<p>Example natural dam formed from large woody material and leaf litter, creating flow variation.</p>

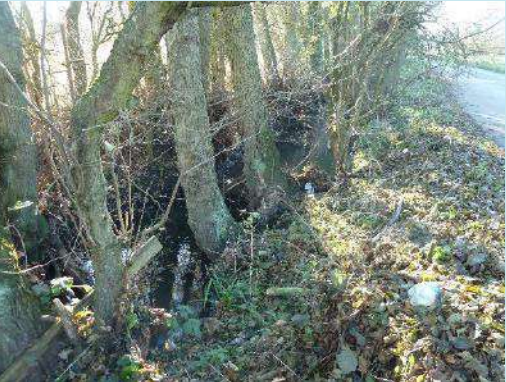
<p>Uniform channel width of approximately 2-3m.</p>

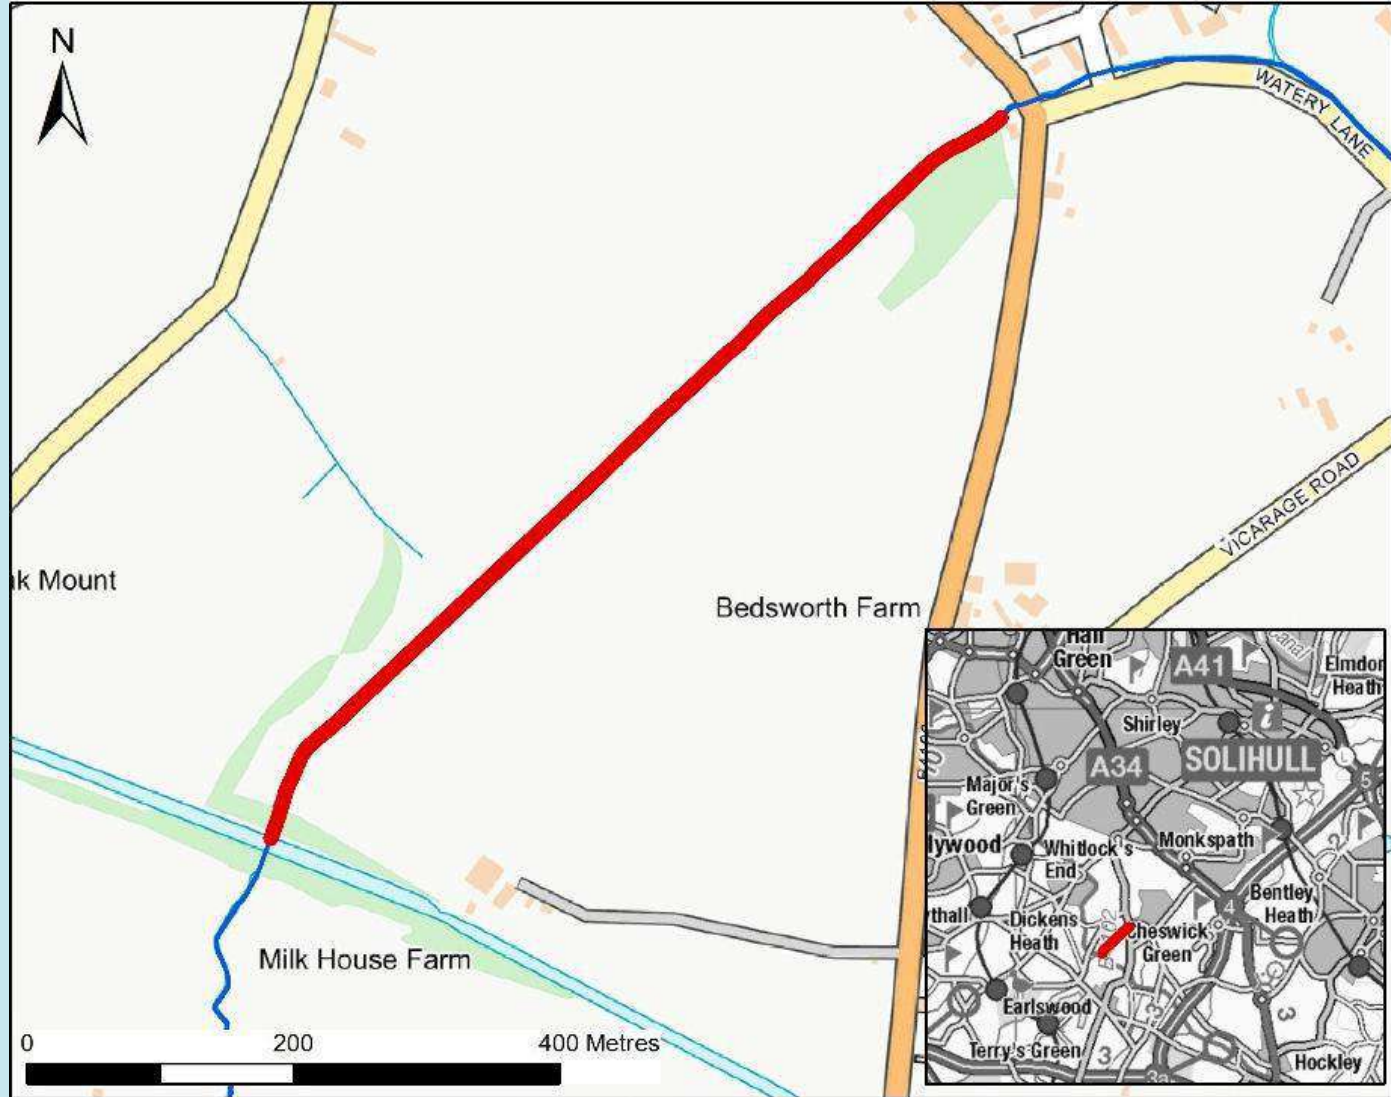
4.3.2 Reach 2: Canal Downstream

Reach Details	Existing Reach Conditions	Reach Overview	Photographs
<p>Start NGR: SP 11768 74976</p> <p>End NGR: SP 12324 75524</p> <p>Reach Length: 781m</p> <p>SSSI Unit: Unit 2</p> <p>SSSI Unit Condition: Unfavourable Recovering</p>	<p>Geomorphology:</p> <ul style="list-style-type: none"> River type is likely passive meandering; however, channel straightening has altered its natural planform. A transporting reach with minimal areas of active deposition. Flow variation and in-channel sinuosity developing around natural dams and woody material. Primarily a glide/ pool reach. Embanked channel with moderate to poor floodplain connectivity. Armoured gravel bed with sands. <p>Ecology:</p> <ul style="list-style-type: none"> <i>Phytophthora alni</i> disease of Alder predominant in this reach. Dead Alder creating large woody material dams promoting channel migration, bar formation and colonisation by Fools Water-cress Reverting (improved) grassland on right bank. Poor fen and rich fen habitats on left bank. Fen areas species-rich but under threat from field drainage

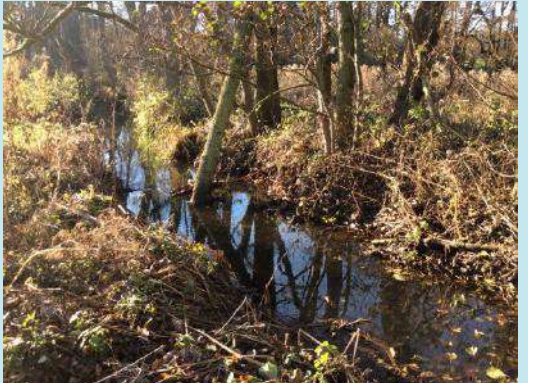
<p>Reach is lined by trees and dense vegetation on both banks. Species-rich fens on left bank.</p>

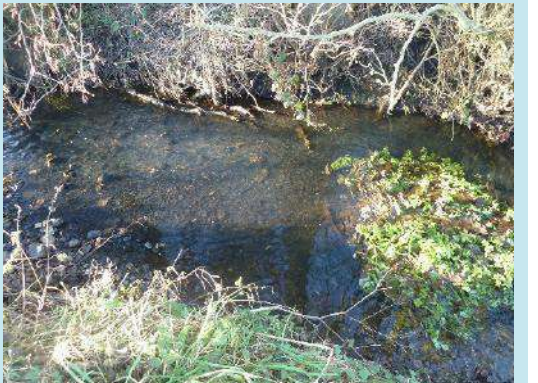
<p>Channel is mostly deep but with some shallower sections, in which the bed substrate appears to be armoured with gravels and sands.</p>

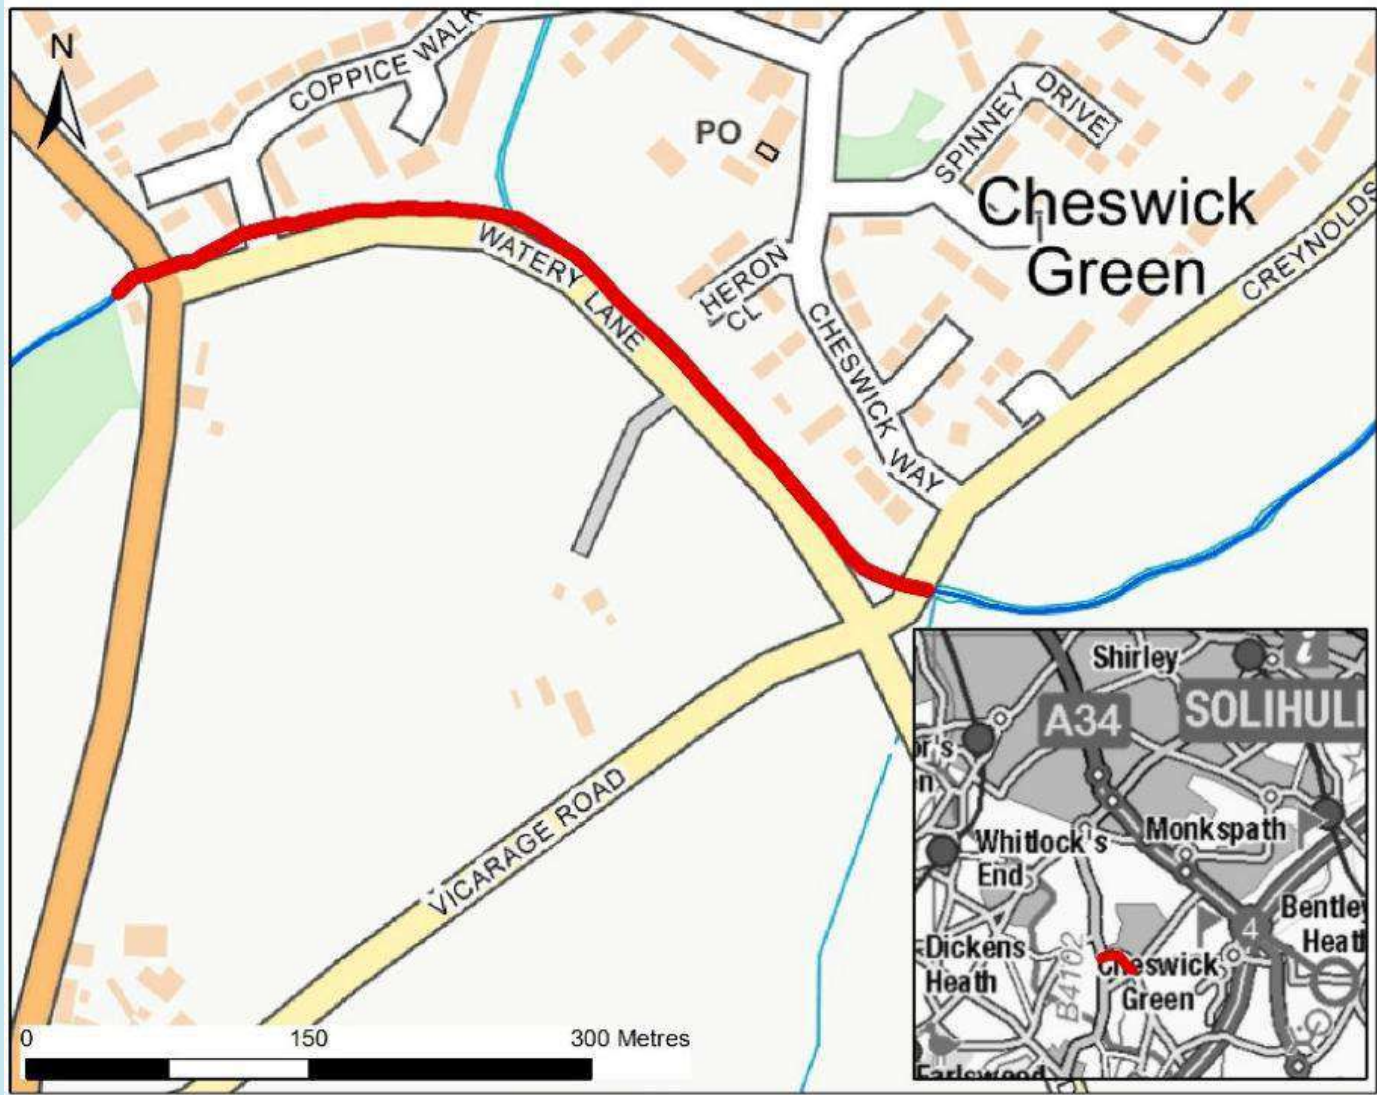
4.3.3 Reach 3: Cheswick Green

Reach Details	Existing Reach Conditions	Reach Overview	Photographs
<p>Start NGR: SP 12324 75524</p> <p>End NGR: SP 12731 75370</p> <p>Reach Length: 521m</p> <p>SSSI Unit: Unit 2</p> <p>SSSI Unit Condition: Unfavourable Recovering</p>	<p>Geomorphology:</p> <ul style="list-style-type: none"> River type is passive meandering, constrained by road. A transporting reach with minimal areas of active deposition. Varying floodplain connectivity; moderate to poor in places but good where lined by formal gardens. Glide/ riffle reach with minimal features, rippled biotope. <p>Ecology:</p> <ul style="list-style-type: none"> Garden escapes (GEs) widespread, including a number of <i>Cotoneaster</i> species and Snowberry. <i>Ranunculus pencillatus pseudofluitans</i> is present on channel bed gravels. Concrete channel walls behind gardens and along Watery Lane negatively impact riparian habitats <i>Carex pendula</i>, a GE, dominant along banks in many locations.

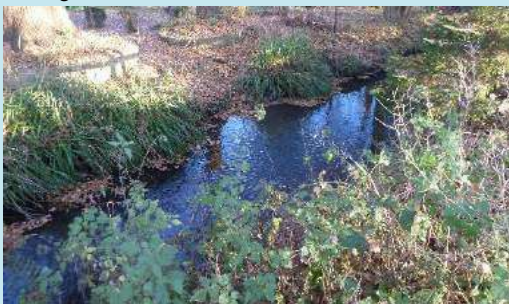
<p><i>Carex pendula</i> dominant on left bank.</p>

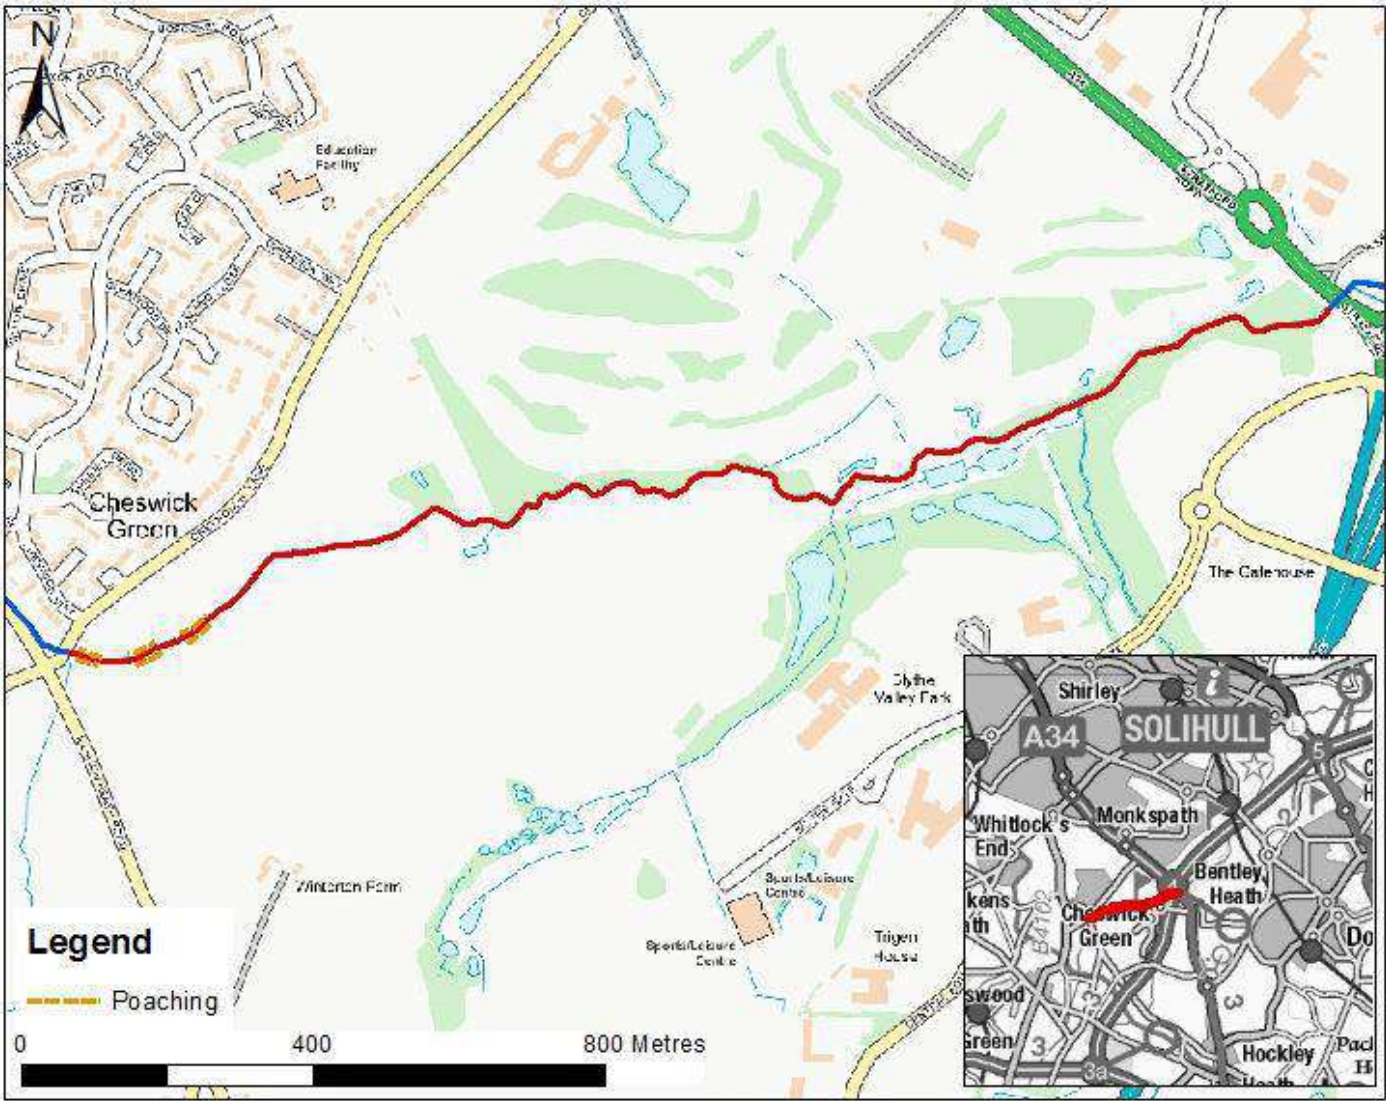
4.3.4 Reach 4: Shirley Golf Course

Reach Details	Existing Reach Conditions	Reach Overview	Photographs
<p>Start NGR: SP 12731 75370</p> <p>End NGR: SP 14462 75824</p> <p>Reach Length: 1995m</p> <p>SSSI Unit: Unit 3</p> <p>SSSI Unit Condition: Unfavourable No Change</p>	<p>Geomorphology:</p> <ul style="list-style-type: none"> River type is passive meandering. Primarily transporting reach, but some areas of temporary deposition. Distinct riffle/ glide sequences, interspersed by runs. Variable channel width and depth. Floodplain connection is moderate, channel is mostly entrenched. Alder disease contributes large woody material in places. <p>Ecology:</p> <ul style="list-style-type: none"> Cattle poaching prevalent in numerous locations along this reach. Large areas of poor fen associated with palaeochannels on right bank. Alder-lining of channel is discontinuous. Bars become colonised by <i>Apium nodiflorum</i>, then <i>Phalaris arundinacea</i> then <i>Carex riparia</i> as they mature. Paleochannels on left bank are conspicuous but species-poor.

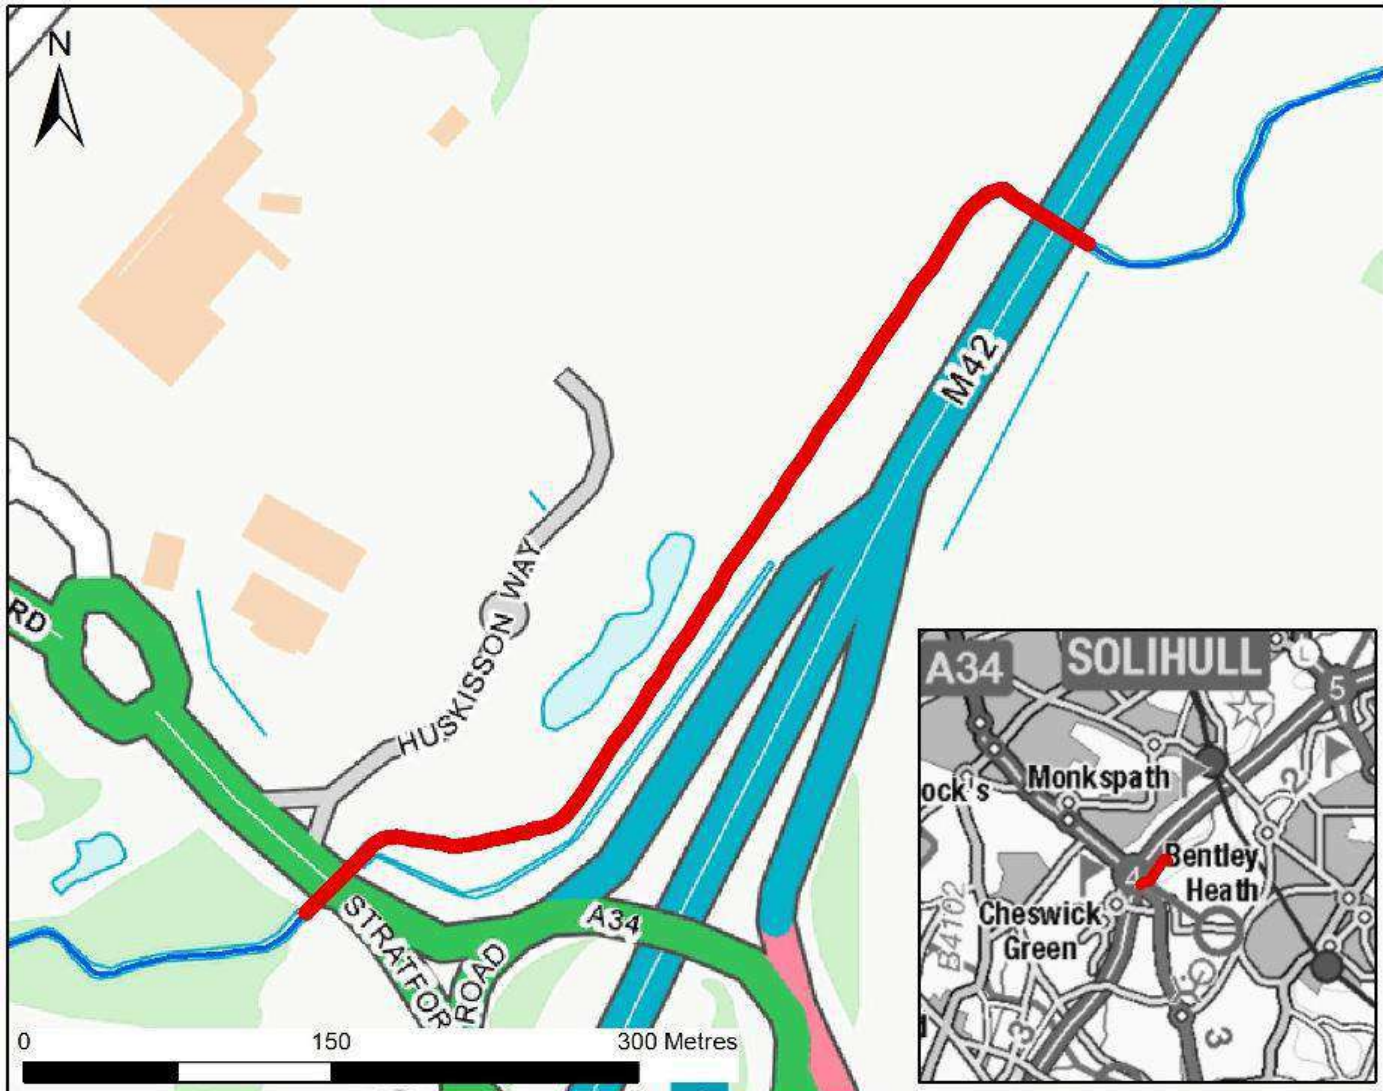
4.3.5 Reach 5: M42

Reach Details	Existing Reach Conditions	Reach Overview	Photographs
<p>Start NGR: SP 14462 75824</p> <p>End NGR: SP 14865 76163</p> <p>Reach Length: 572m</p> <p>SSSI Unit: Unit 4</p> <p>SSSI Unit Condition: Unfavourable No Change</p>	<p>Geomorphology:</p> <ul style="list-style-type: none"> River type is likely passive meandering; however, channel straightening has altered its natural planform. Primarily transporting reach, with few areas of active deposition. Relatively confined floodplain; M42 on right and gradual sloping valley on left. Channel banks are vertical, not trapezoidal. Heavily modified reach alongside the M42 with a narrow strip of floodplain on the left bank <p>Ecology:</p> <ul style="list-style-type: none"> Crack Willow <i>Salix fragilis</i> is the dominant tree on this reach. Old course of river is now a group of ponds. Banks are unmanaged and land use has tumbled down to ruderal grassland with invading tree and shrub species. No in-channel vegetation. Off line ponds on left bank are less than 10 years old, connected to each other and main channel upstream. Much of channel is very shaded, with a silty bed. Angling is taking place and fishing line has been left lying about.

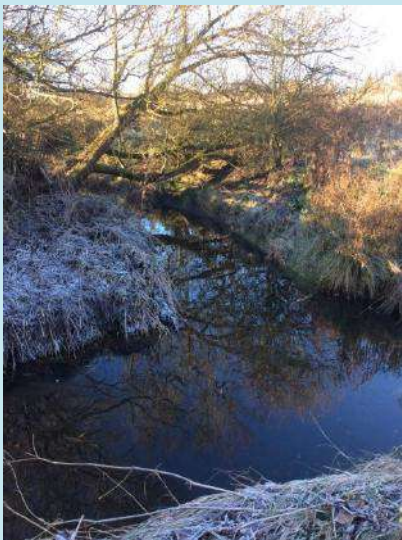
<p>Sharp-right hand bend in channel; over-widened through culvert and access ramp for large machinery.</p>

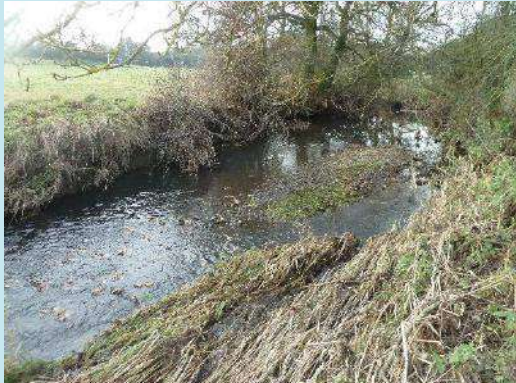
<p>Gravel mid-channel island in the upper reach, with colonising Foo's Water-cress.</p>

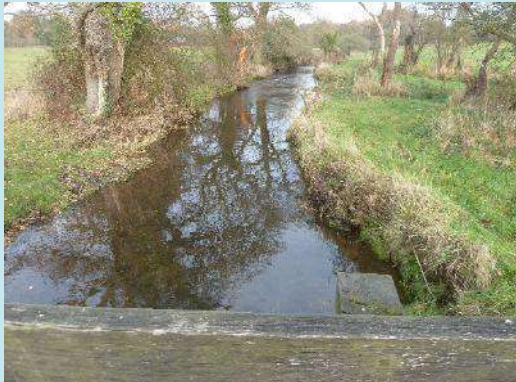
<p>Although considered passive meandering, there are relatively straight sections characterised by gliding flows.</p>

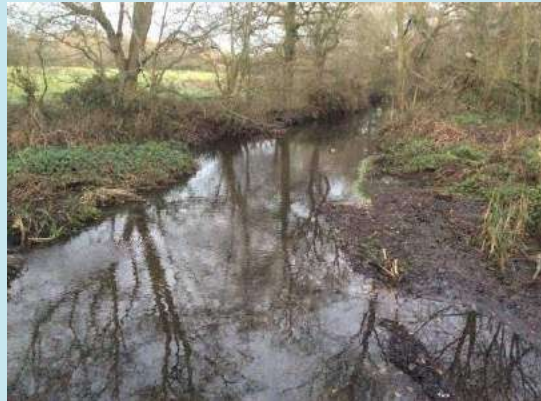
<p>Wooded reach showing areas of deposition</p>

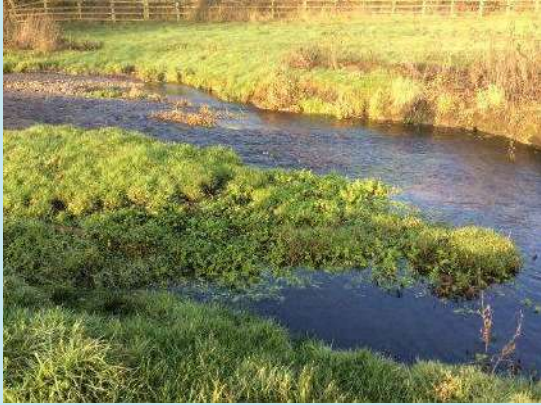
<p>Some deposition in the form of mid-channel bars and point bars.</p>

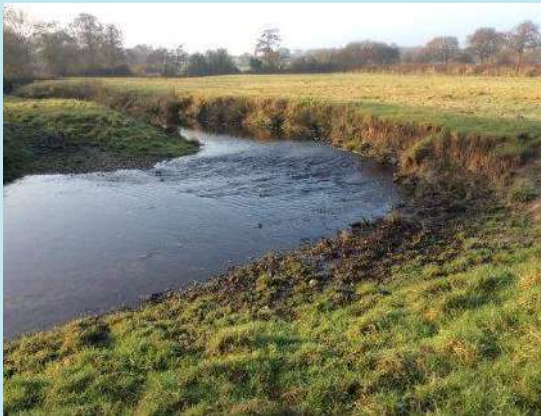
<p>Grazed banks, poaching and lack of trees in places is assisting with erosion.</p>

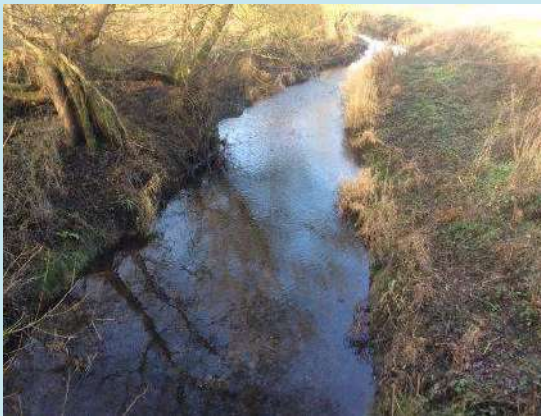
<p>Straightened section with sluggish flow.</p>

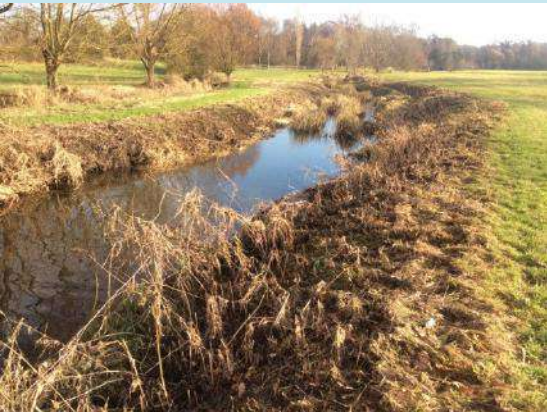
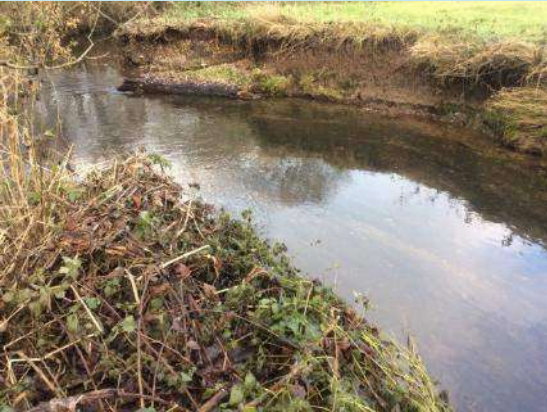
<p>Bank erosion and instability is evident in the reach.</p>

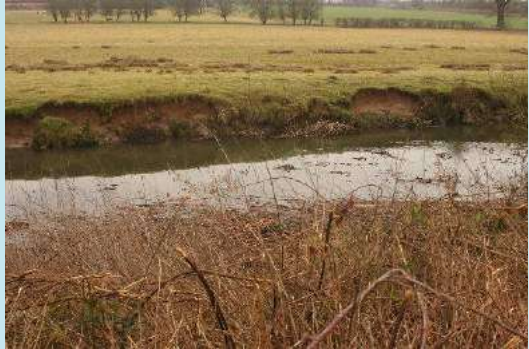
<p>Areas of active bank instability and slumping on straightened reach suffering sheep grazing.</p>

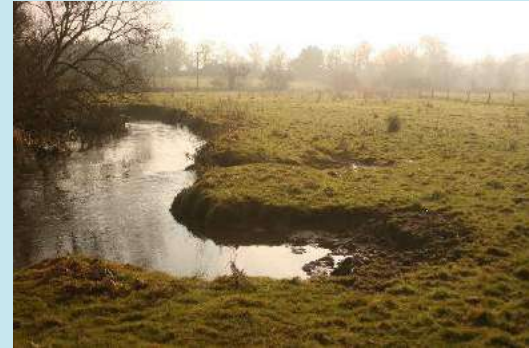
<p>Cattle grazing and watering causing poaching on banks that are not tree-lined.</p>

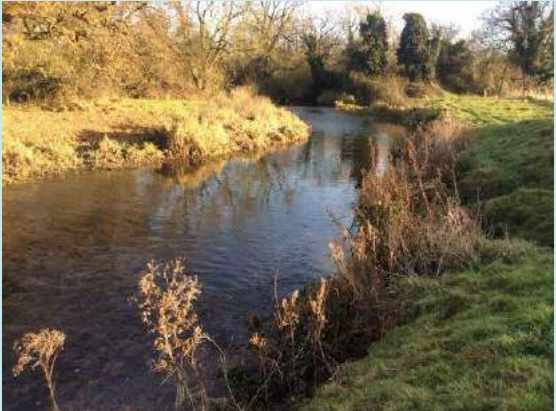
<p>Sequence of glide morphology leading into deeper pools. Clean but armoured gravels visible in shallower glides.</p>

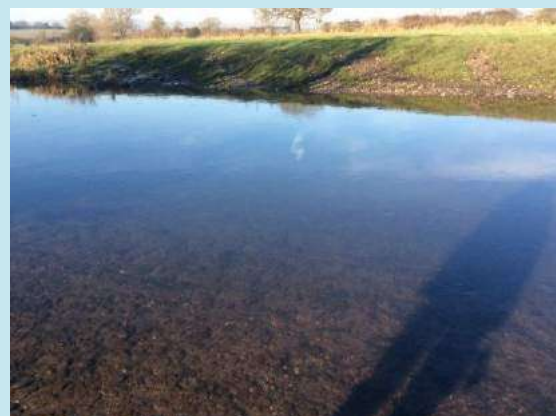
<p>Gravel and sandy bed substrate covered by a layer of fine sediment. Likely originating from local sources; potentially the grazed fields behind.</p>

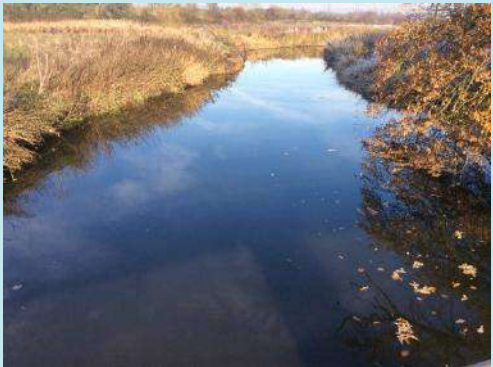
<p>Lone tree on the right bank with open rushy pasture on the left bank.</p>

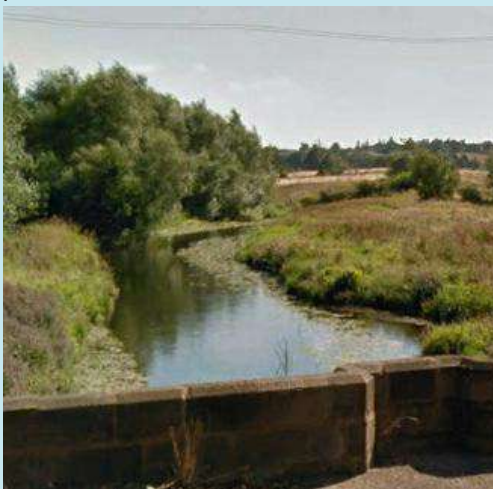
<p>Rushy pasture on the L bank and rich fen on the right bank looking South (upstream). Bridge Plantations represent virtually the only trees in this reach.</p>

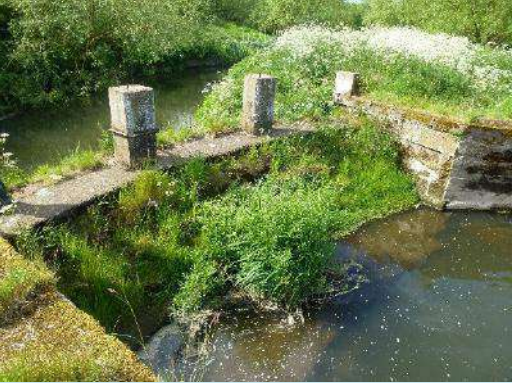
<p>Old sluice structure in channel</p>

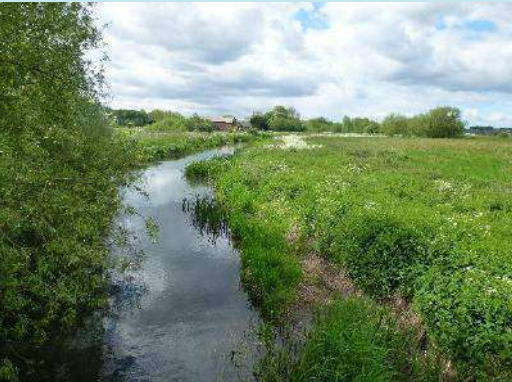
<p>Upstream view of river morphology towards Mill</p>

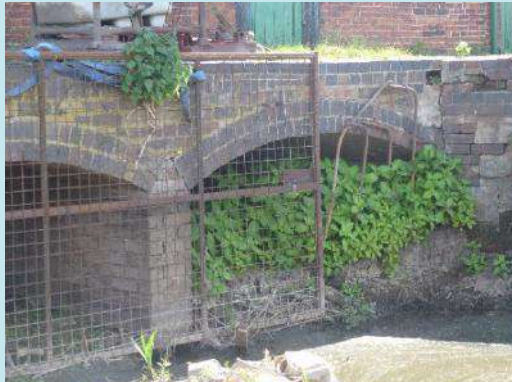
<p>Himalayan Balsam in Mill building</p>

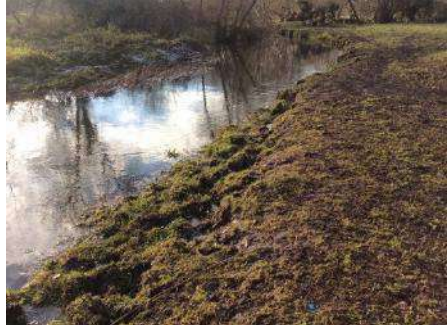
Bank Instability and Livestock pressures Bank instability as a result of poaching from livestock, poor farming practices in places, and entrenchment of the channel.	Livestock have utilised the collapsed banks to gain access to the river in a number of locations leading to enhanced erosion of the banks (poaching). Arable farming, where carried out up to the channel edge, has limited riparian vegetation cover and exacerbated bank erosion. Increased input of fine sediment into the channel which leads to increase in channel siltation. A more uniform channel reduces the habitats within the river (i.e. fewer refuges for shelter). Limited bankside vegetation due to erosion and as a result a decline in habitat.

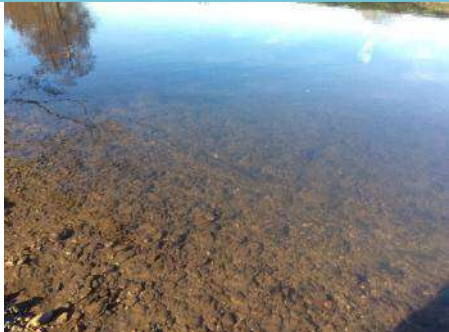
Channel Realignment In many areas, the channel has been straightened as a result of infrastructure creation (canals, railways and motorways). In addition, it has been straightened in places for farming and land use purposes.	The river has responded to straightening in various ways. In some areas, where the channel has been over-widened, excessive fine sediment deposition has occurred across the bed. In other areas, minor incision has occurred, leading to some river and floodplain disconnectivity.

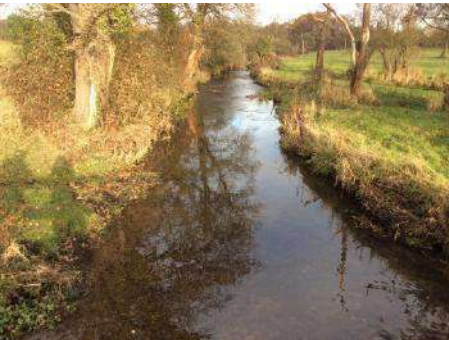
Floodplain Management and Riparian Pressures Current and historic floodplain farming practices have altered the semi-natural habitats and vegetation on the floodplain and the channel in places.	The floodplain contains significant areas of wet grassland and rushy pasture, as well as areas of rich fen. There is a lot of riparian woodland, mainly Alder trees, but in one or two reaches (16 in particular) there is a lack of woody riparian vegetation. Farming practices have affected the floodplain in two ways: intensification of arable and pasture management and extensification through land abandonment.

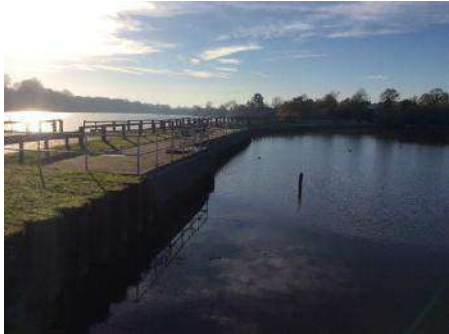
<p>Discharge: Abstraction, Diversion and Impoundment of flows</p> <p>Earlswood Lakes, constructed between 1822 and 1823 for the purposes of retaining water levels in the Stratford upon Avon canal via flow diversion, and the reservoir at Whitacre used for public water supply, certainly impact the flow regime of the River Blythe.</p>	<p>Whilst not considered to affect the low flows through the River Blythe, the large impoundment reservoirs at Earlswood Lakes attenuate large volumes of water and will impact by reducing high flows being released into the channel. Limiting the high flows in the upper catchment impacts upon sediment transport mechanisms.</p>

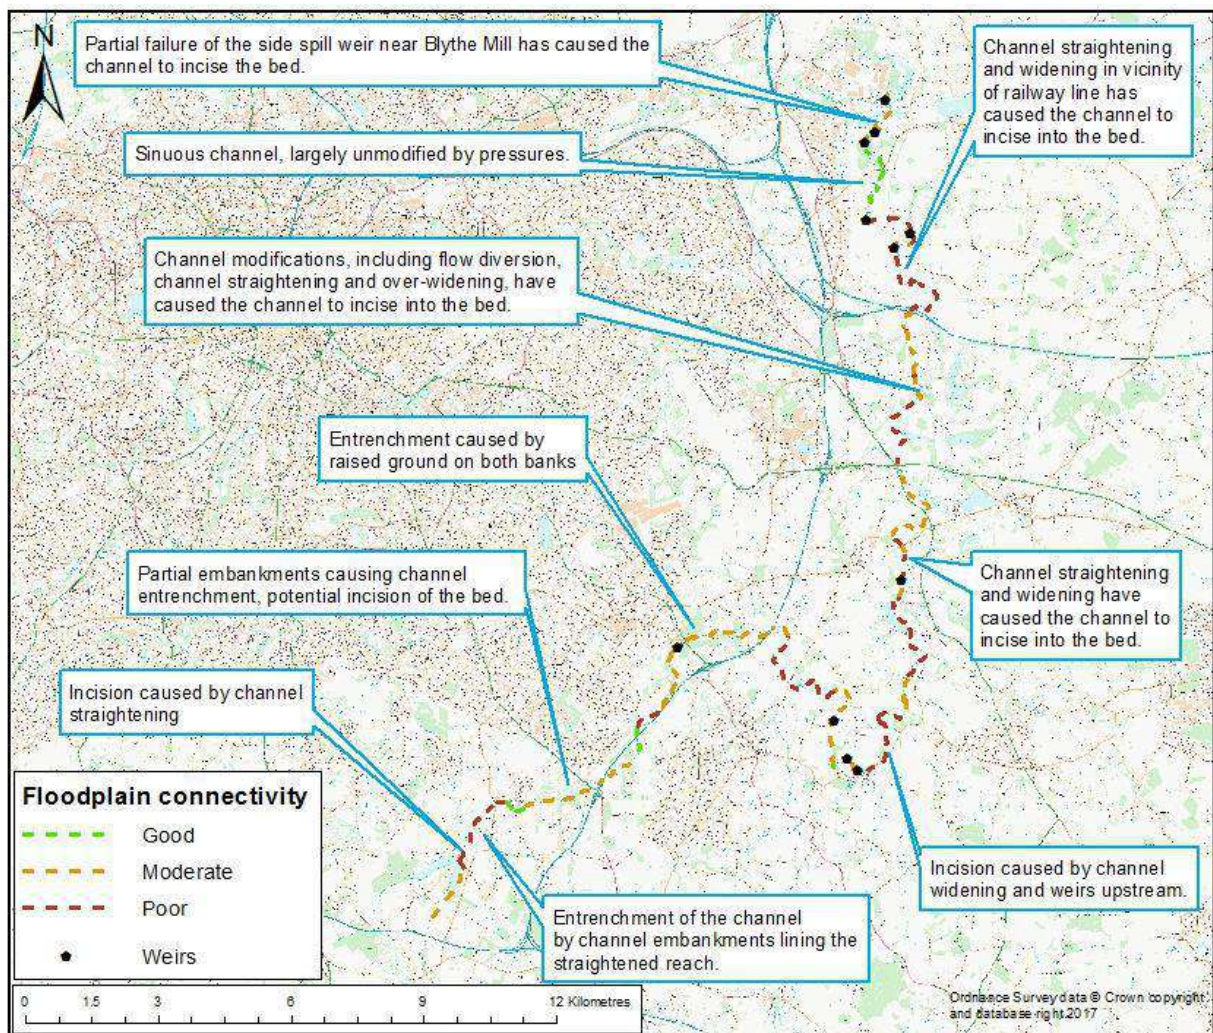
Figure 5-1: Channel floodplain connectivity through the Blythe SSSI

Floodplain connectivity is variable across the Blythe SSSI. Figure 5-1 shows an assessment of the channel floodplain connectivity determined from the geomorphological walkover. A rating of either good, moderate, or poor has been assigned based on how well connected the floodplain was considered to be, although the majority of the watercourse is considered to be entrenched and consequently has poor connectivity to its floodplain.

Channel incision is shown to occur most prominently downstream of weirs, and whilst upstream the channel may be impounded for a short length which gives the impression of improved connectivity,

many reaches are still considered to be disconnected, mostly owing to the channel being overly wide in many places downstream and east of the M42.

This is not the case in all reaches in the Blythe SSSI, however; some reaches which have not had their planform historically straightened or diverted, have good connection to their floodplain and would likely flood during the winter months. Figure 5-1 shows some sections of the channel which are considered to have good connectivity to its floodplain; for instance, the channel between Shelly Coppice and the Shelly Green golf course is well connected, and inundation of the floodplain would be expected.

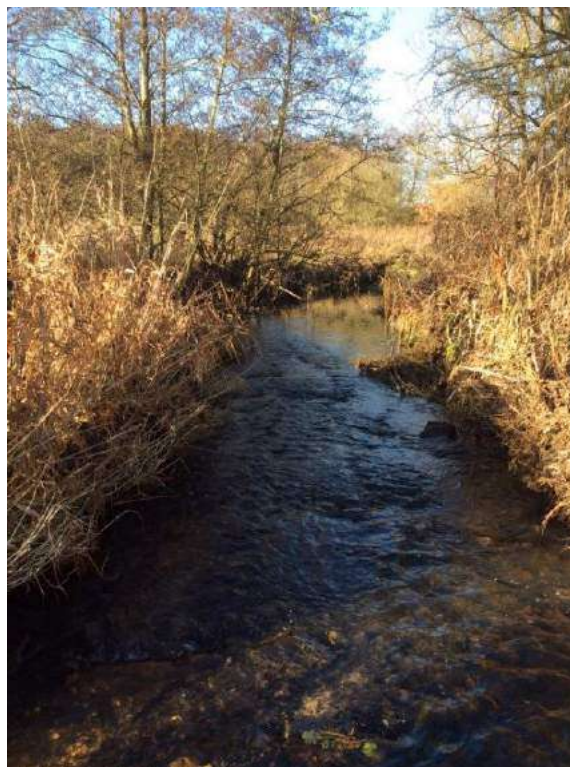
Figure 5-2: Photo example of good connectivity through Shelly Coppice

The presence of large woody material in certain reaches, such as through Coppice Wood, also contributes to better connectivity, by creating localised impoundment. Some reaches are reasonably sinuous and are actively forming vegetated berms through deposition; however, still have a way to go before connectivity is improved.

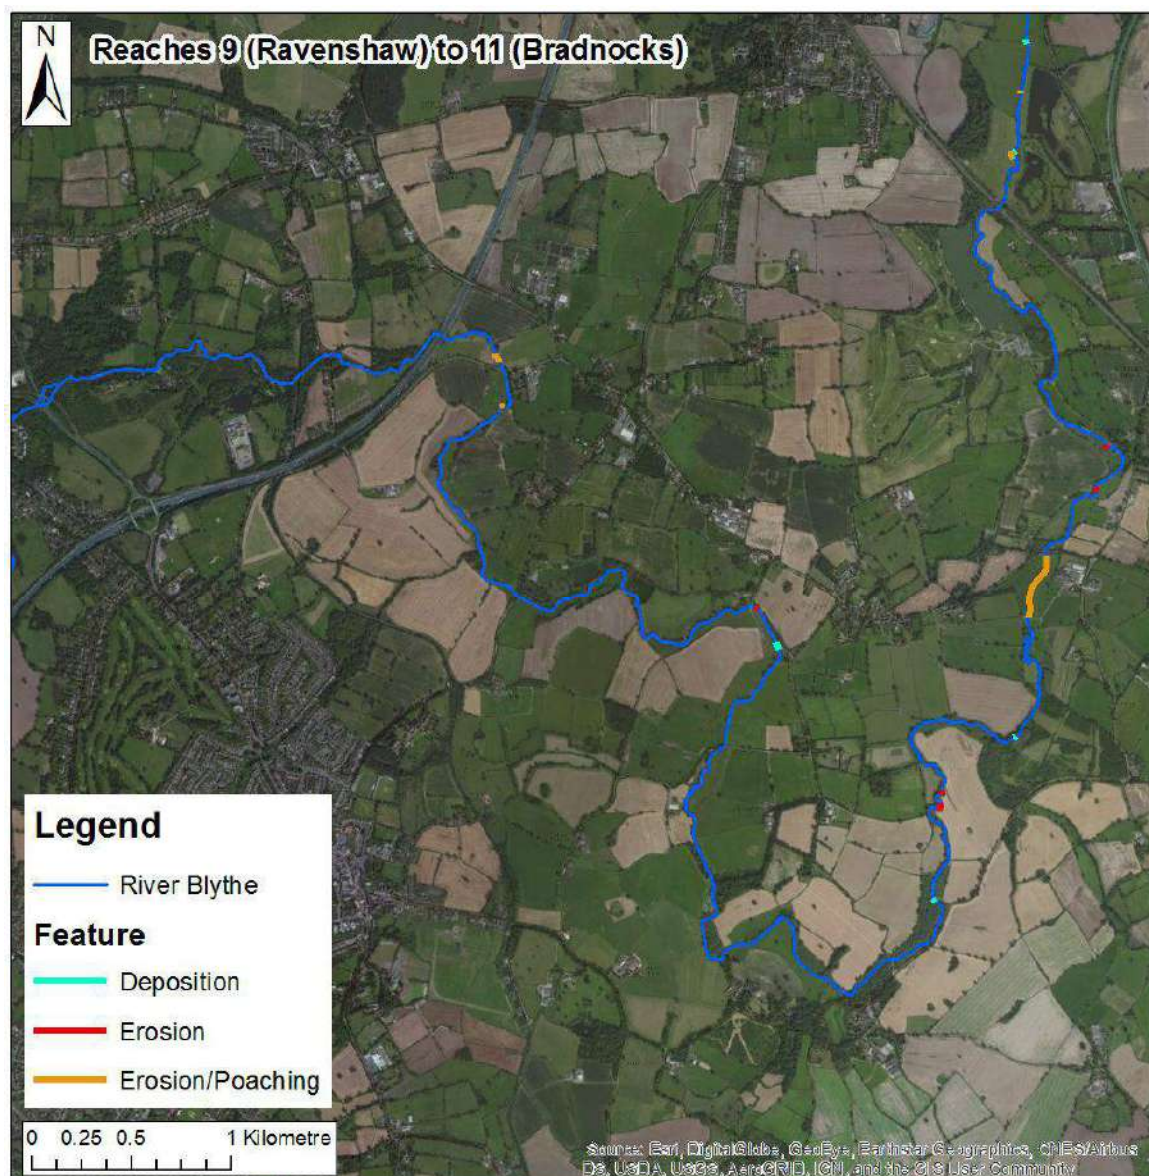
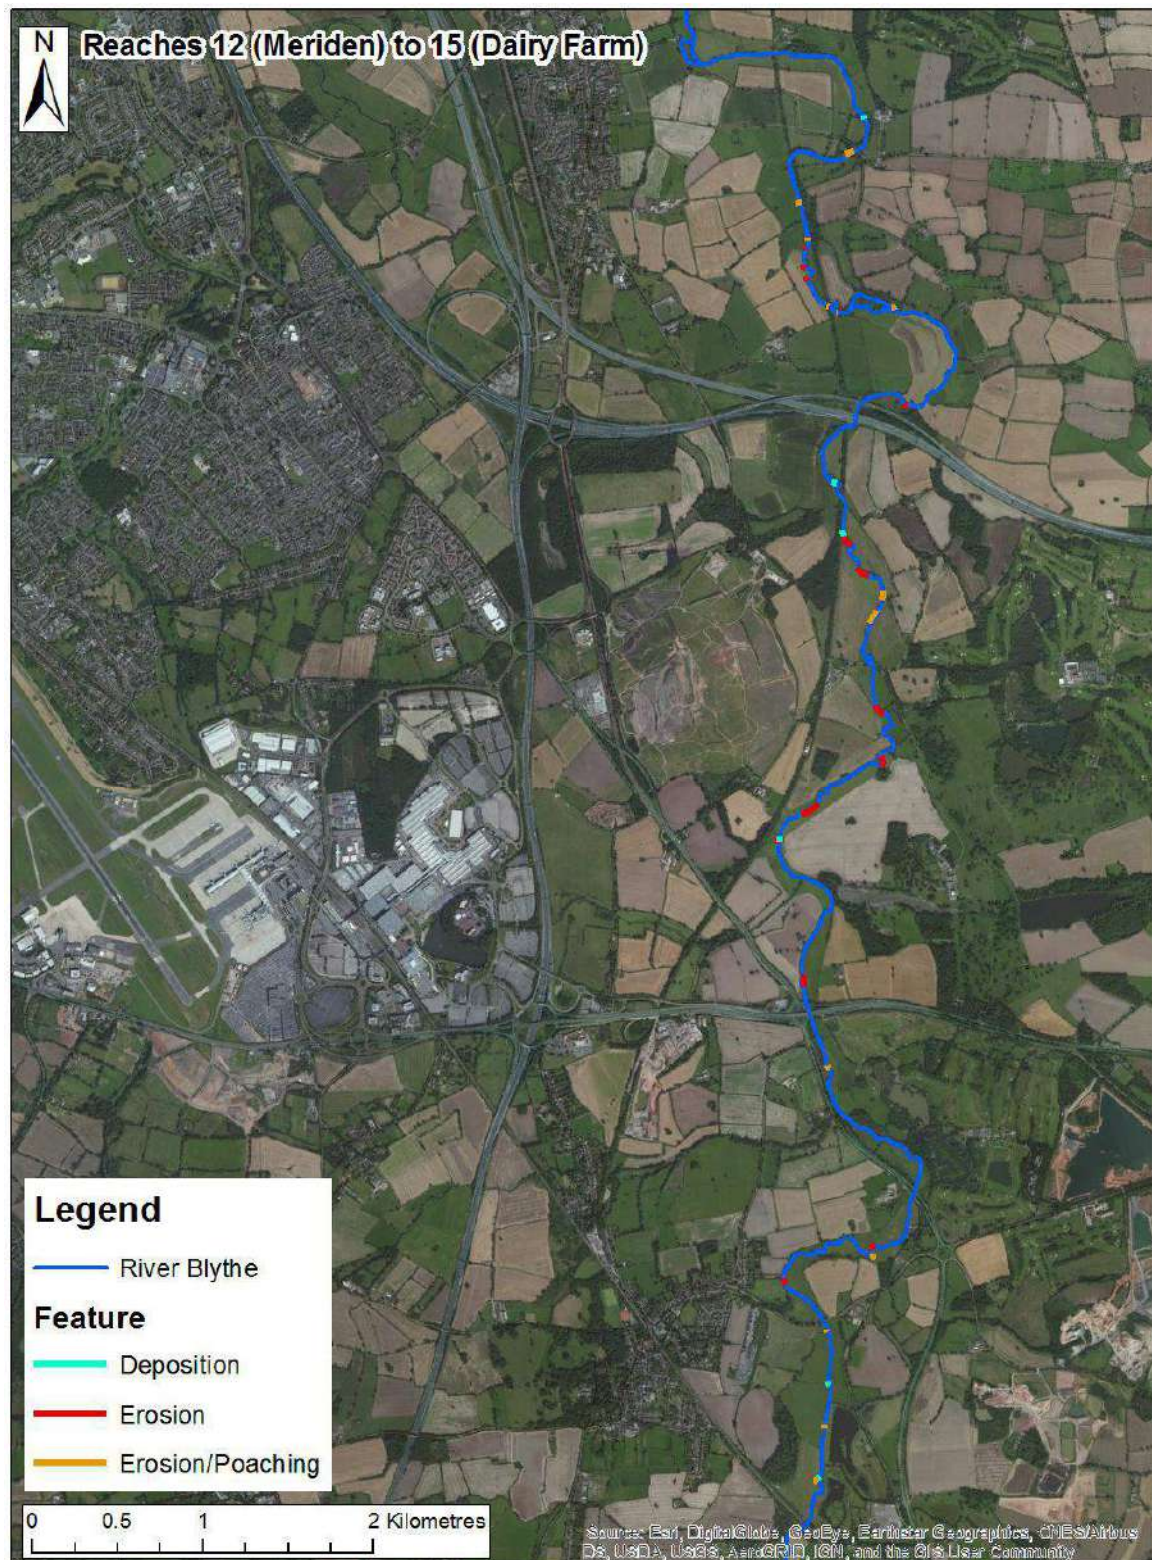
Figure 5-4: Key erosional and depositional features

Areas of significant bank erosion and depositional features have been mapped and shown in Figure 5-4. Whilst there are some localised pockets, bank erosion from hydraulic action does not occur prominently in the upper reaches from Earlswood Lakes to Ravenshaw. Active bank erosion, such as scour and undercutting, features more in the reach around Barston, Meriden and Brook Farm, typically occurring on the outside meanders. Whilst this suggests the channel is trying to increase its sinuosity on a very localised scale, it is not considered prominent enough to classify the river type as active meandering,

The observed areas of bank erosion, including erosion from hydraulic action and from poaching by livestock, are most prominent where the riparian zone is degraded, limited or completely absent. It also appears to be linked with land-use, occurring mostly in areas used for agricultural purposes. Poaching of the banks by livestock is a significant contributor to bank erosion in the Blythe SSSI, and provides a significant source of fine sediment to the watercourse.
